Asbestos-Containing Materials and Lead-Based Paint Survey
2089 Harbor Boulevard, Costa Mesa, California

09 August 2013
AGE-SC-13-2893

AGE Project No. SC-13-2893

**Subject: Asbestos-Containing Materials and Lead-Based Paint Survey,
2089 Harbor Boulevard, Costa Mesa, California**

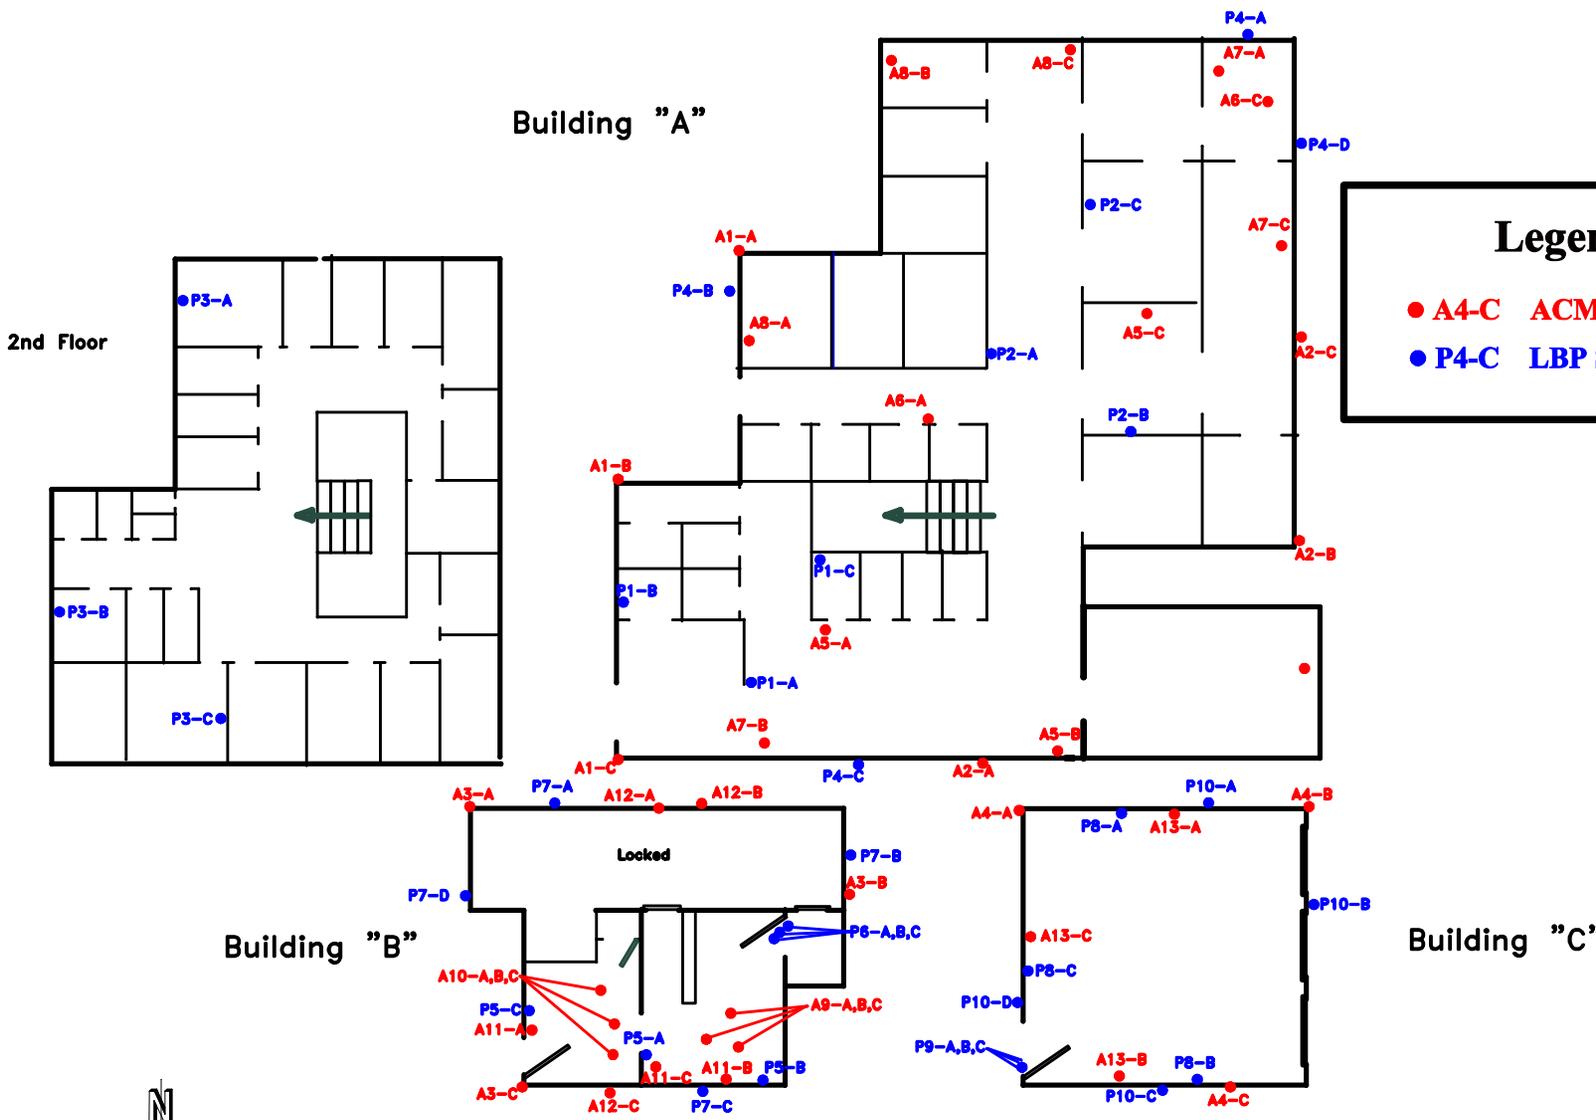
FIGURE 3 - Sample Locations

Figure 3 depicts the locations where samples of ACM and lead-based paint were collected. Asbestos samples are prefixed with the letter "A," and lead-based paint samples are denoted by the letter "P."

Power was not available in this unit, and all doors and windows were boarded up. Approximately one-third of the interior walls were broken down, making estimation of the coverage difficult. All but one sample of interior crème coatings reported concentrations of lead in paint in excess of the CALOSHA standard. Concentrations ranged from 0.0489% dry weight (Sample #P1-C, collected from a SE Office) to 0.119%wt, found in the office adjacent to the kitchen (Sample #P2-C). The offices on the second floor were a uniform light blue. Samples of these coatings were collected, and analytical results indicate that none of the coatings contain concentrations of lead above the established limit of 0.06% dry weight. **A very rough estimate of 3,000 square feet (ft²) of the crème coating is present throughout the building.**

The exterior of Building "A" is coated with what could be described as "Battleship Grey" paint. Samples of this coating were collected from each side of the structure. Analytical results indicate that this exterior coating contains lead at levels above the 0.5% safety limit established by HUD as well as the allowable concentration of lead in paint (0.06% dry weight), as determined by CalOSHA. Sample concentrations ranged from 1.51%wt reported in Sample #P4-A taken from the north side of the building, to 1.71%wt, collected from the west side, more than 25 times higher than the CALOSHA limit. **There are approximately 6,230 ft² of this coating present on the exterior surfaces of Building "A."**

Since lead-based paint has been identified in the surface coatings of Building "A," specific procedures must be followed when conducting demolition. Section 105250 of the California Health and Safety Code is implemented by Title 17, Division 1, Chapter 8, of the California Code of Regulations. It outlines specific practices which must be adhered to once a positive determination of the presence of hazardous levels of lead has been made. Further, Title 17, Chapter 8 of the Code outlines work practices for lead-related construction. In brief, they are:
