PARKS AND RECREATION COMMISSION AGENDA REPORT

SUBJECT: TREE REMOVAL REQUEST - 3198 SICILY AVENUE

DATE: JULY 11, 2013

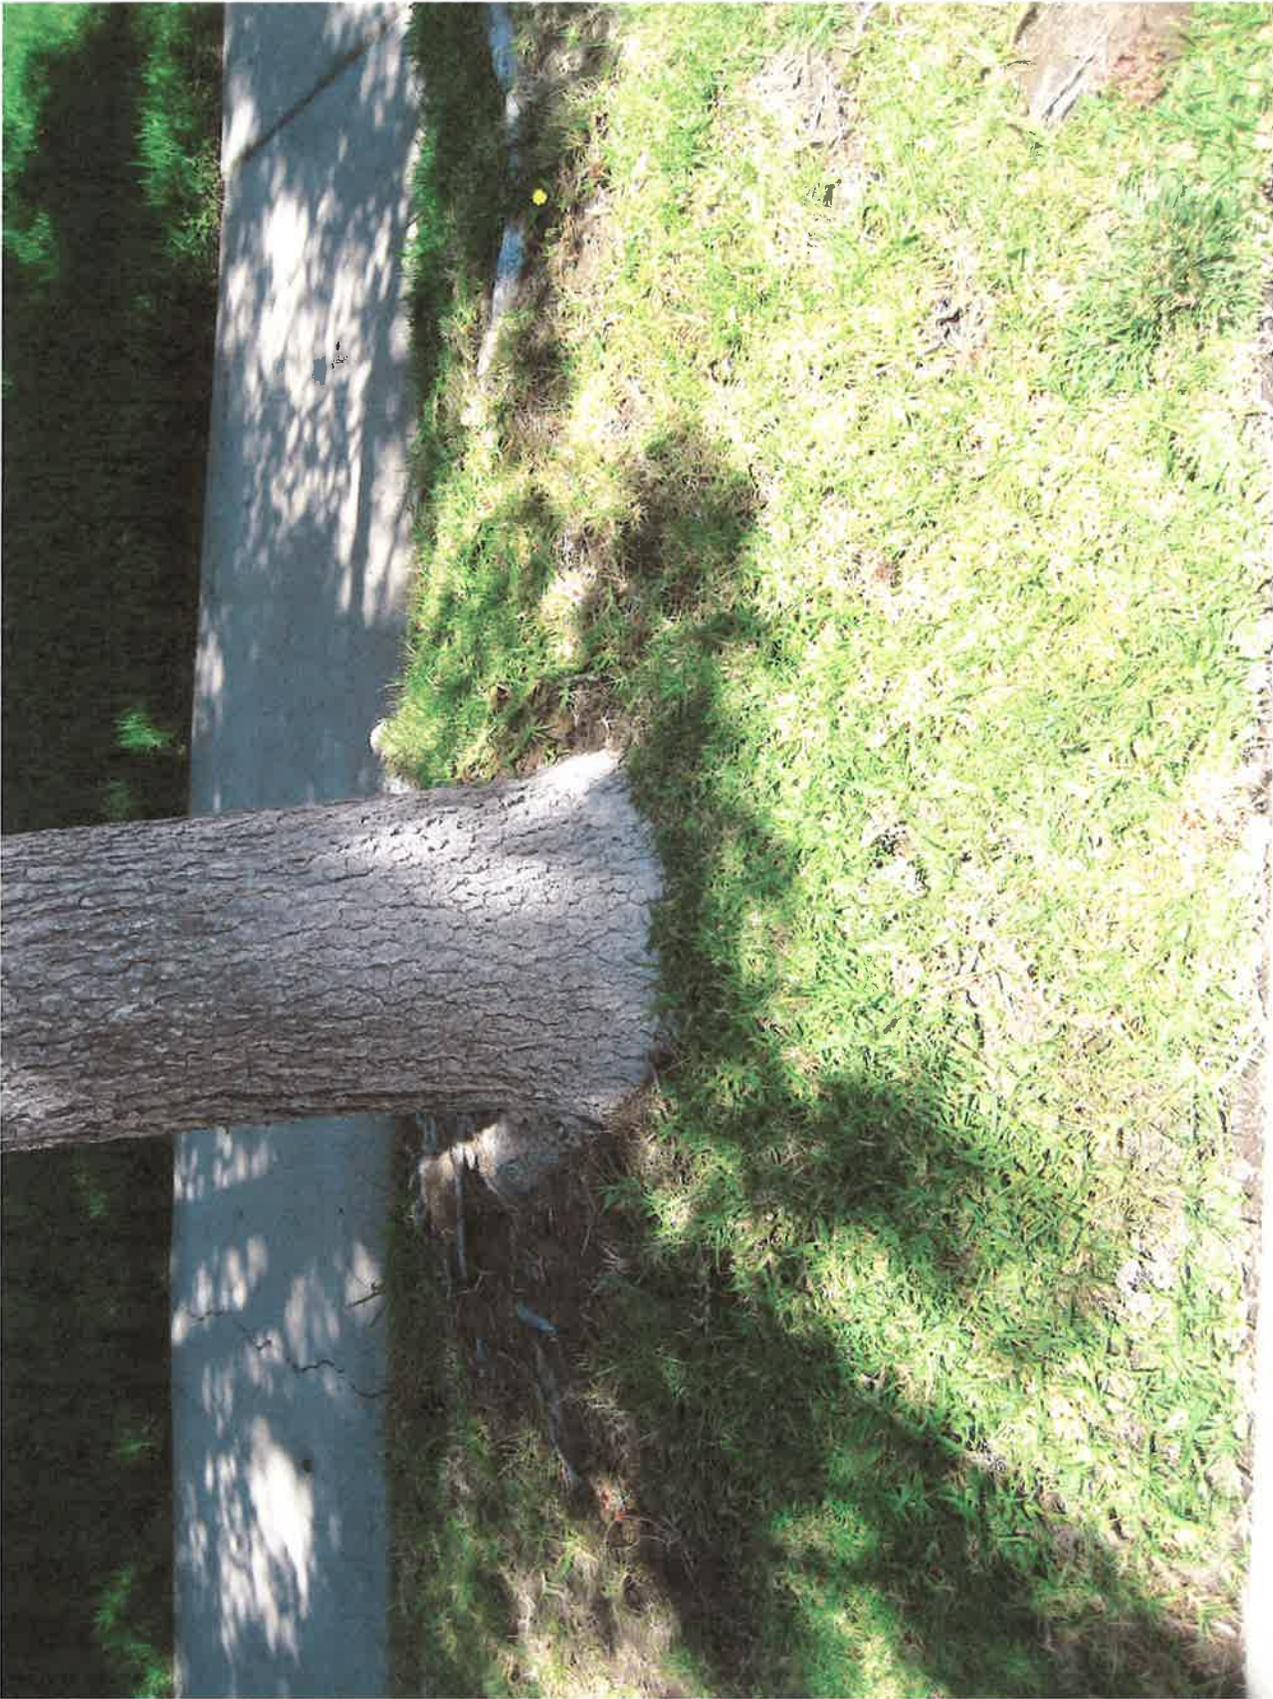
TREE #1 (F1) BASE

If Yes, describe damage: **Cracked and lifted sidewalk, cracked curb. No trip hazard.**

Root Pruning Comments: **The tree was root pruned on 7/30/2012 along the sidewalk. There is no new concrete damage.**

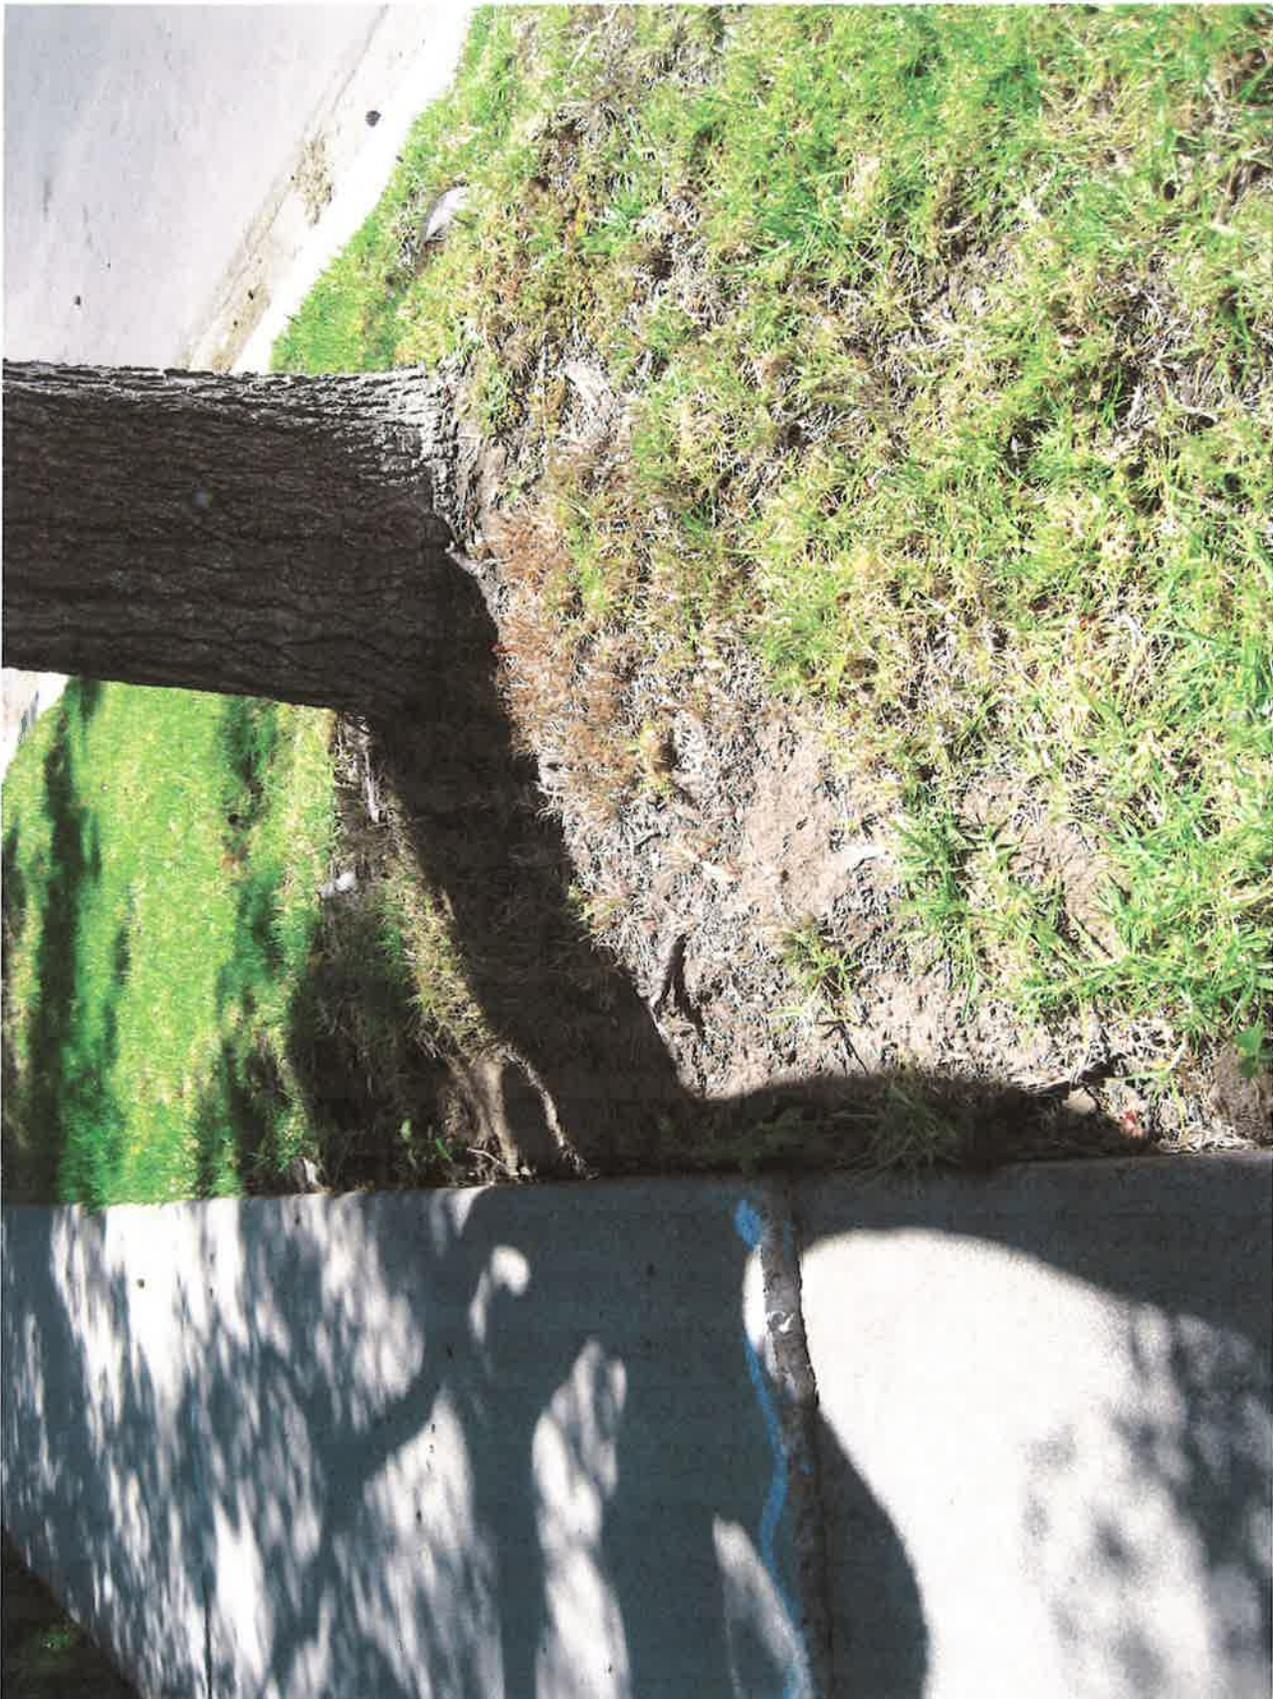
TREE #2 (F2) BASE

If Yes, describe damage: **Cracked and lifted sidewalk, 1 ½” lift in the path of travel.**

Root Pruning Comments: **The tree was root pruned on 7/30/2012 along the sidewalk. Tree roots continue to lift sidewalk.**
