# FACILITY CONDITION ASSESSMENT

Bridge Shelter  
3175 Airway Avenue  
Costa Mesa, CA 92626

171582.25R000-017.354

August 14, 2025

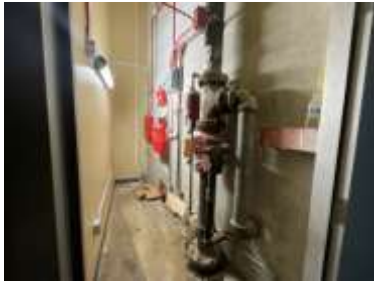
### Fire Suppression System in Failed condition.

Existing Sprinkler Heads, by SF  
017-Bridge Shelter  
Throughout Building

Sprinkler pipes in the laundry room leaked during the inspection. The cause is being investigated. -  
AssetCALC ID: 9609797

Uniformat Code: D4010  
Recommendation: **Replace in 2025**

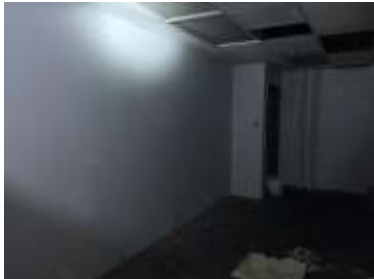
### Interior Remodel

Down Unit/Space, Total Gut & Rehab  
017-Bridge Shelter  
Second floor

Second floor is damaged and requires rehabilitation - AssetCALC ID: 9610917

Uniformat Code: C1010  
Recommendation: **Renovate in 2025**

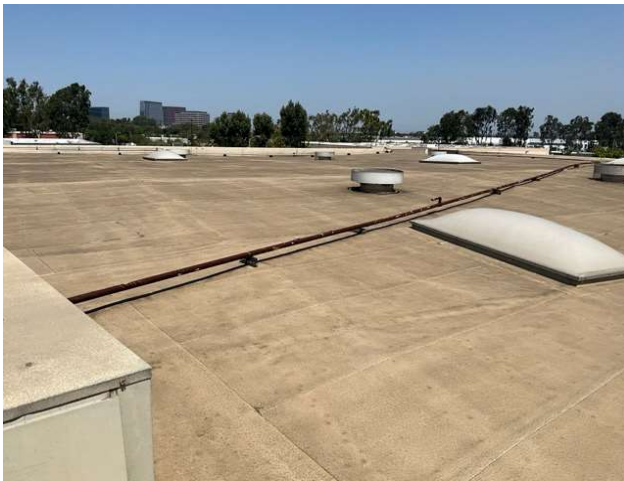
3 - ROOF

Overall, the building is in good structural condition following a retrofit five years ago. The roof, also five years old, exhibits surface bubbling and an uneven walking surface, indicating fair to poor condition, though no active leaks were observed. The second floor (approximately 2316 SF) sustained sprinkler leakage, resulting in significant damage and temporary non-use, with repairs in progress. Interior finishes, particularly carpeting in common areas and break room, show accelerated wear beyond their typical life expectancy. Ongoing preventative maintenance and periodic deep cleaning are recommended to preserve functionality and extend the service life of finishes and systems.
