FACILITY CONDITION ASSESSMENT

Fire Station #1
2803 Royal Palm Drive
Costa Mesa, CA 92626

August 14, 2025

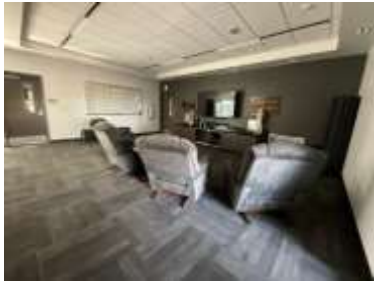
Mechanical, HVAC Controls / Rebalance
016-Fire Station #1
Throughout

Overall, the MEPF systems are relatively new and in good condition. The original solar water heater system, however, failed and has since been replaced with a new gas commercial unit. During the summer months, the building experiences persistent humidity issues, suggesting that the HVAC system may be undersized or malfunctioning. A comprehensive HVAC study is recommended to pinpoint the cause and develop targeted corrective measures to restore optimal indoor comfort and performance.

Per point of contact, the building experiences excessive humidity during the summer, likely due to an inadequate or malfunctioning HVAC system. An HVAC study is recommended to determine the root cause and identify necessary corrective actions. - AssetCALC ID: 9610165

Uniformat Code: P2030
Recommendation: **Evaluate/Report in 2025**

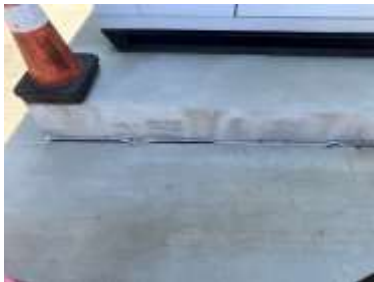
Structural, Superstructure
016-Fire Station #1
Generator Foundation

The site is well maintained, with landscaping in good condition, adequate lighting, and parking lots and walkways free of cracks. However, a visible gap along the generator foundation may indicate settlement, separation, or deterioration of joint material. A comprehensive structural assessment is recommended to determine the cause and implement corrective measures to preserve the site's integrity and performance.

A visible gap has developed along the generator foundation, as shown in the attached image. This condition may indicate settlement, separation, or deterioration of the joint material. A more detailed structural assessment is recommended to determine the cause and appropriate corrective action. - AssetCALC ID: 9610164

Uniformat Code: P2030
Recommendation: **Evaluate/Report in 2025**

Site Additional Studies	A structural study is recommended to investigate the root cause of the gap observed in the generator foundation.	
Site Areas Observed	Most of the exterior areas within the property boundaries were observed to gain a clear understanding of the site's overall condition.	
Site Key Spaces Not Observed	All key areas of the exterior site were accessible and observed.
