FACILITY CONDITION ASSESSMENT

Fire Station #4
2300 Placentia Avenue
Costa Mesa, CA 92626

June 26, 2025

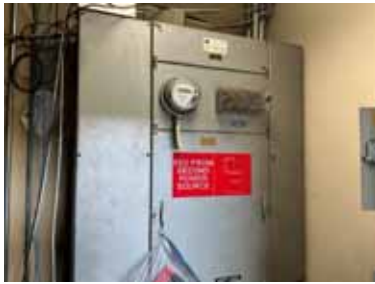
Switchboard in Poor condition.

120/208 V
 008 - Fire Station #4
 Electrical Room

Obsolete and undersized - AssetCALC ID: 9407716

Uniformat Code: D5020
 Recommendation: **Replace in 2025**

Cost Estimate: \$64,900

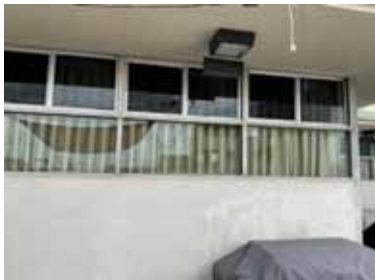
Glazing in Poor condition.

any type by SF
 008 - Fire Station #4
 Building Exterior

All single pane and leaking - AssetCALC ID: 9407752

Uniformat Code: B2020
 Recommendation: **Replace in 2025**

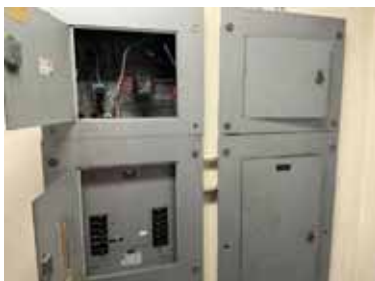
Electrical System in Poor condition.

Wiring and Switches, High Density/Complexity
 008 - Fire Station #4
 Throughout Building

Original single phase system is undersized and insufficient for a fire station - AssetCALC ID: 9407748

Uniformat Code: D5030
 Recommendation: **Replace in 2025**

Cost Estimate: \$48,300

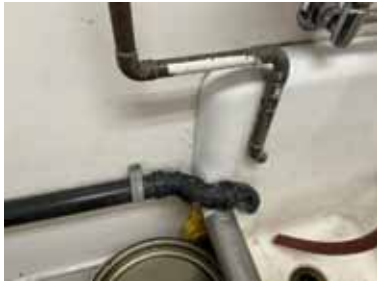
Plumbing System in Poor condition.

Low flow and backups are common - AssetCALC ID: 9407757

Uniformat Code: D2010
 Recommendation: **Replace in 2025**

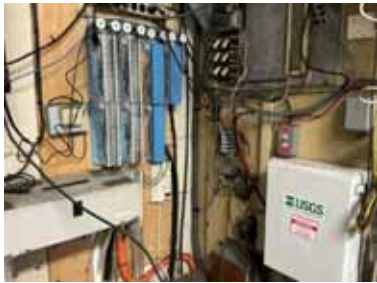
Low Voltage System in Poor condition.

Antiquated phone system is not sufficient given that it's a fire station. - AssetCALC ID: 9407673

Uniformat Code: D6020
 Recommendation: **Replace in 2025**

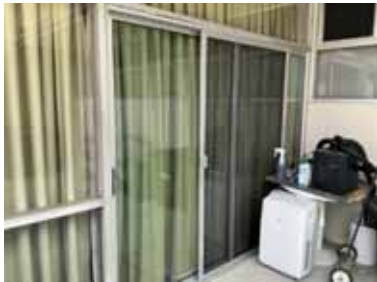
Exterior Door in Poor condition.

Functionality is poor at best - AssetCALC ID: 9407745

Uniformat Code: B2050
 Recommendation: **Replace in 2025**

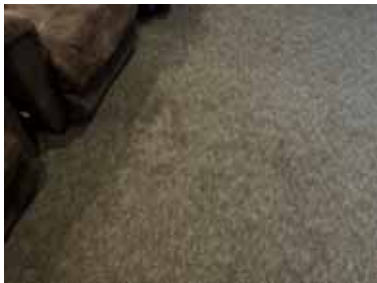
Flooring in Poor condition.

Stained throughout, extremely worn - AssetCALC ID: 9407720

Uniformat Code: C2030
 Recommendation: **Replace in 2026**

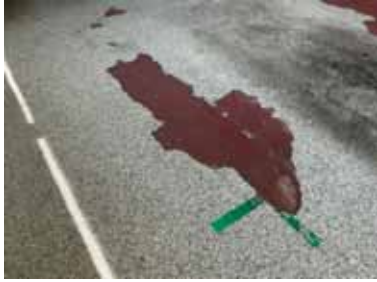
Flooring in Failed condition.

any surface, w/ Epoxy Coating
008 - Fire Station #4
High bay

Uniformat Code: C2030
Recommendation: **Prep and Paint in 2026**
