# FACILITY CONDITION ASSESSMENT

Mesa Verde Library  
2969 Mesa Verde Drive East  
Costa Mesa, CA 92626

*171582.25R000-012.354*

*July 3, 2025*

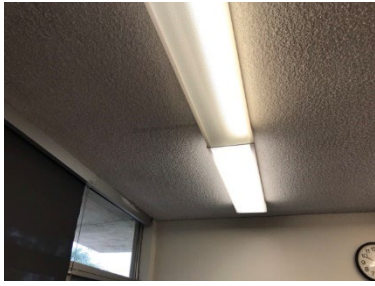
#### Roofing in Poor condition.

Any type, Repairs per Man-Day  
Mesa Verde Library  
Kitchen

Roof leaks were reported throughout, repair is required. - AssetCALC ID: 9431314

Uniformat Code: B3010  
Recommendation: **Repair in 2025**

Cost Estimate: \$4,100

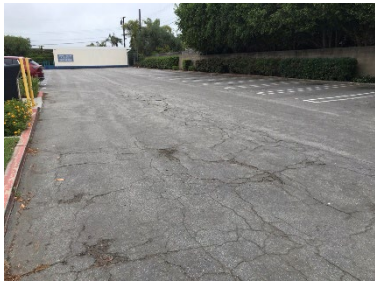
#### Parking Lots in Poor condition.

Pavement, Asphalt  
Mesa Verde Library  
Site Parking Areas

Isolated areas of potholes and cracks, repair is required. - AssetCALC ID: 9431320

Uniformat Code: G2020  
Recommendation: **Repair in 2025**

Cost Estimate: \$4,100

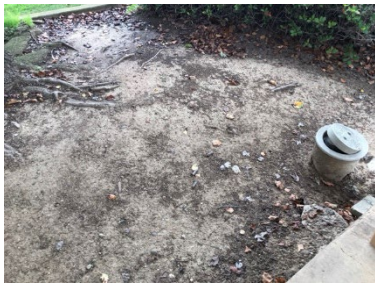
#### Landscaping

Mature Trees, Removal/Trimming  
Mesa Verde Library  
Rear of building

Drainage issue was reported due to tree roots. Repair is required. - AssetCALC ID: 9431309

Uniformat Code: G2080  
Recommendation: **Repair in 2025**

Cost Estimate: \$3,000
