FACILITY CONDITION ASSESSMENT

Police Substation
567 West 18th Street
Costa Mesa, CA 92627

171582.25R000-014.354

July 2, 2025

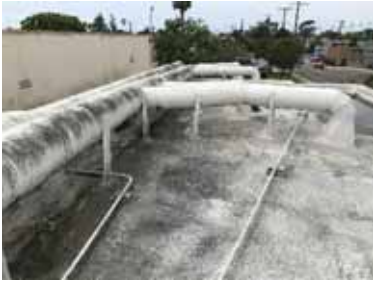
Roofing in Poor condition.

Built-Up
014 - Police Substation
Roof

Roof leaks were reported throughout, roof replacement is recommended. - AssetCALC ID: 9414044

Uniformat Code: B3010
Recommendation: **Replace in 2026**

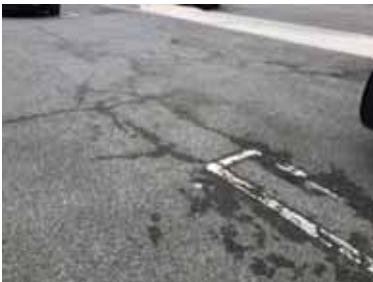
Parking Lots in Poor condition.

Pavement, Asphalt
014 - Police Substation
Site Parking Areas

Isolated area of cracks and potholes, repair is required. - AssetCALC ID: 9414025

Uniformat Code: G2020
Recommendation: **Repair in 2025**

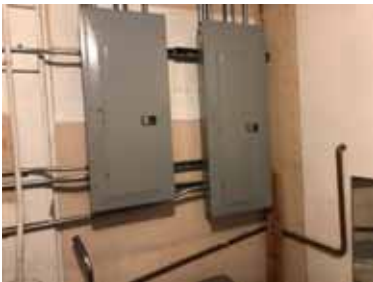
Electrical System in Poor condition.

Wiring & Switches, Average or Low
Density/Complexity
014 - Police Substation
Throughout Building

System is original and does not meet the demand, system upgrades is recommended. - AssetCALC ID: 9414064

Uniformat Code: D5030
Recommendation: **Replace in 2026**

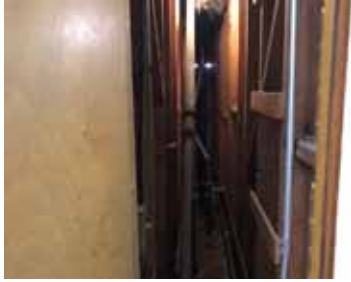
Plumbing System in Poor condition.

Supply & Sanitary, Medium Density (excludes fixtures)

Original system, old pipes with frequent clogging. System replacement is recommended. - AssetCALC ID: 9414052

Uniformat Code: D2010
Recommendation: **Replace in 2026**
