PARKS AND RECREATION COMMISSION AGENDA REPORT

SUBJECT: TREE REMOVAL REQUEST - 259 PRINCETON DRIVE

City of Costa Mesa
Maintenance Services Division
FIELD INSPECTION – TREE INFORMATION

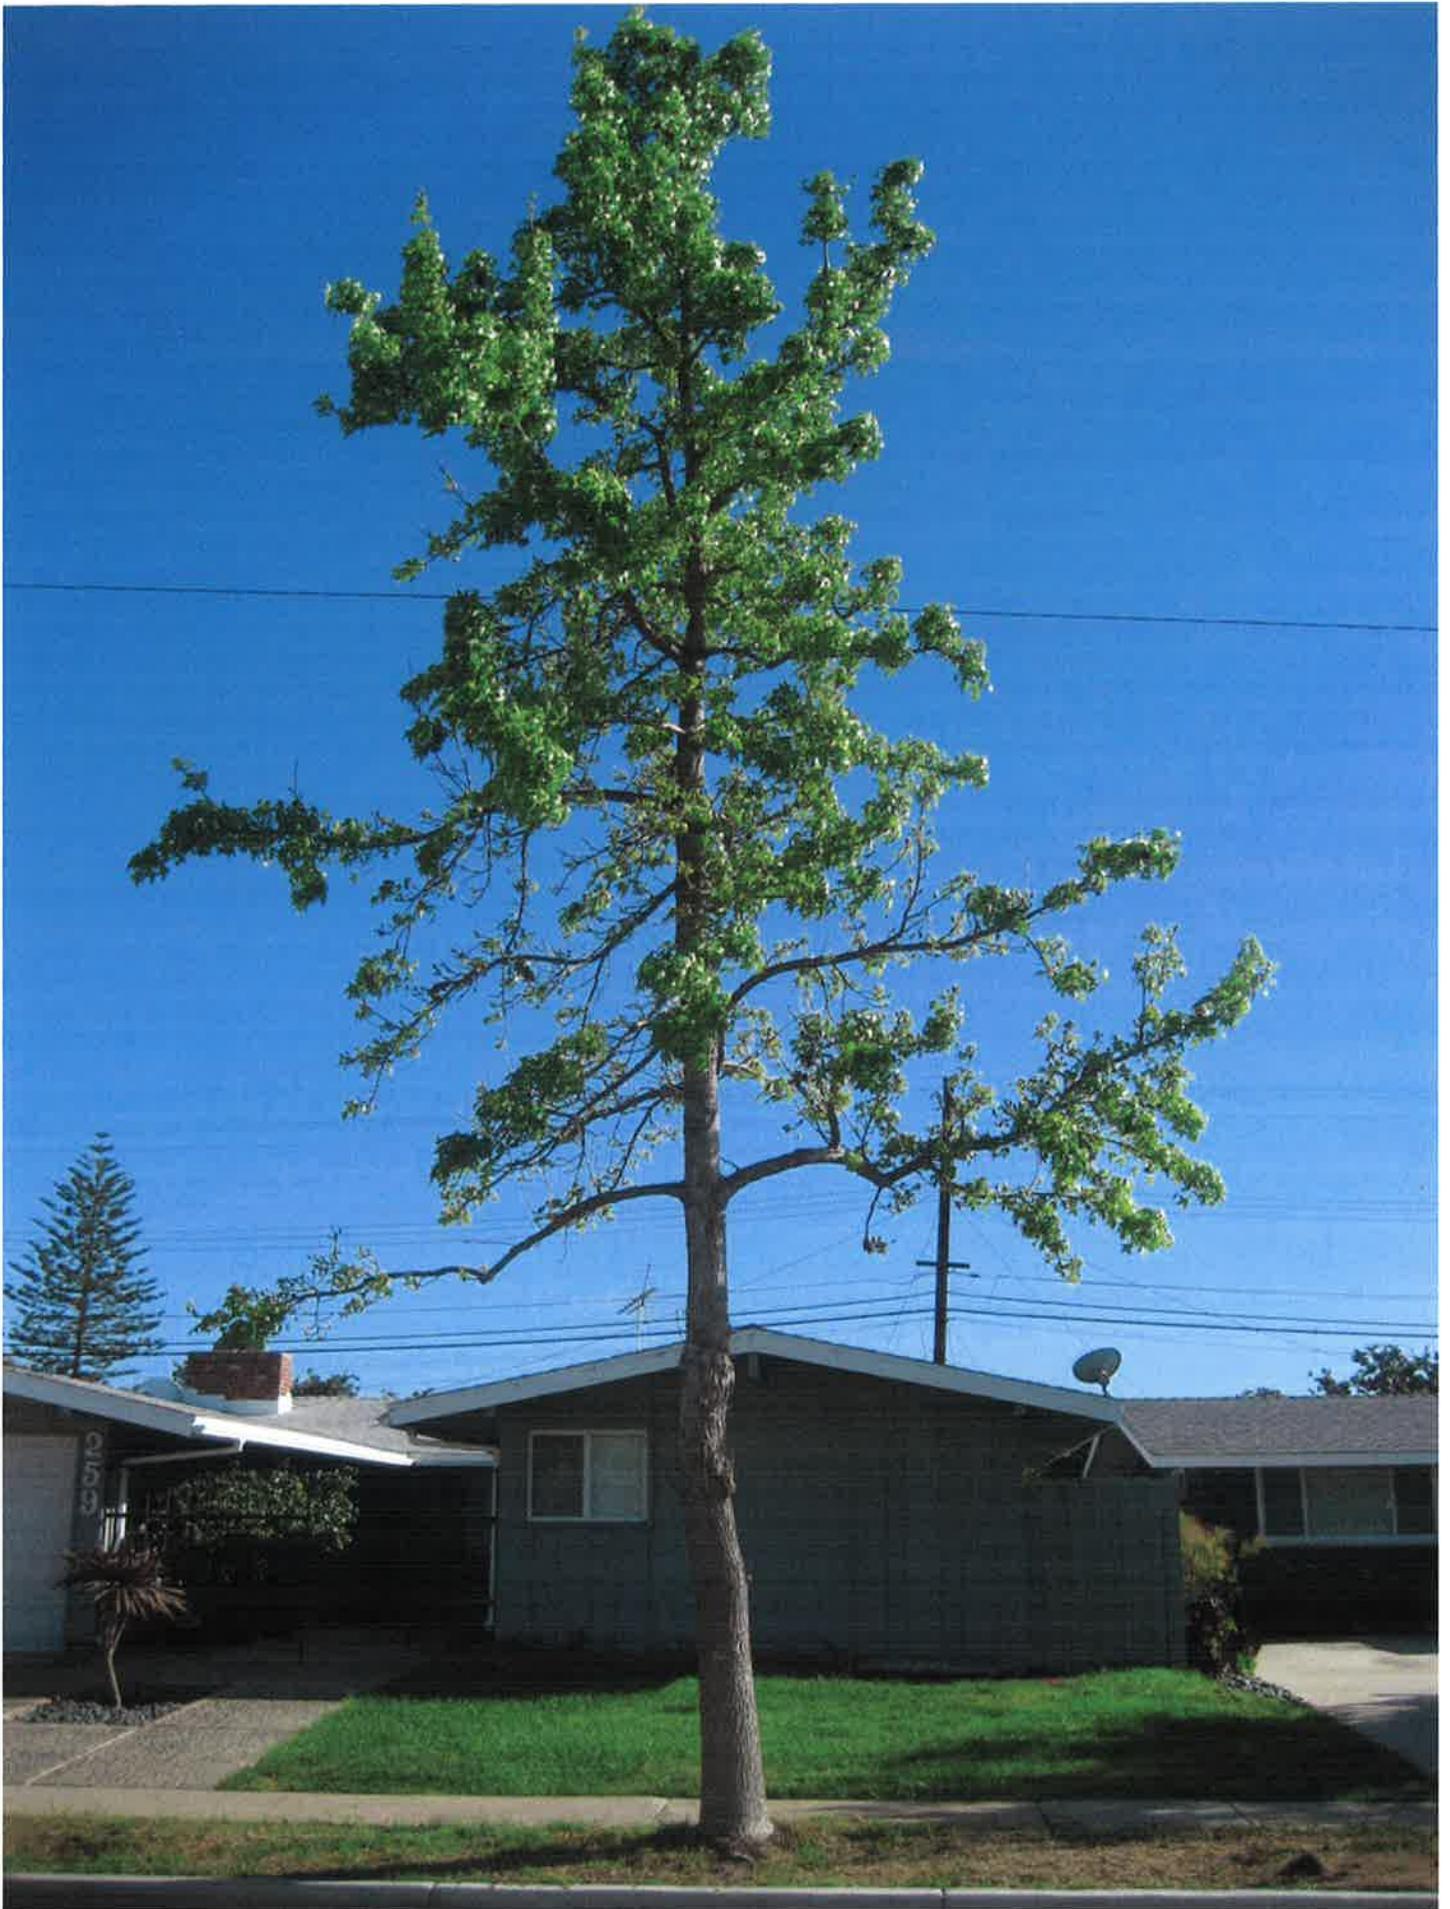
Photo #1: Street view looking south
Photo #2: Street view looking east
Photo #3: Street view looking west
Photo #4: Base of tree

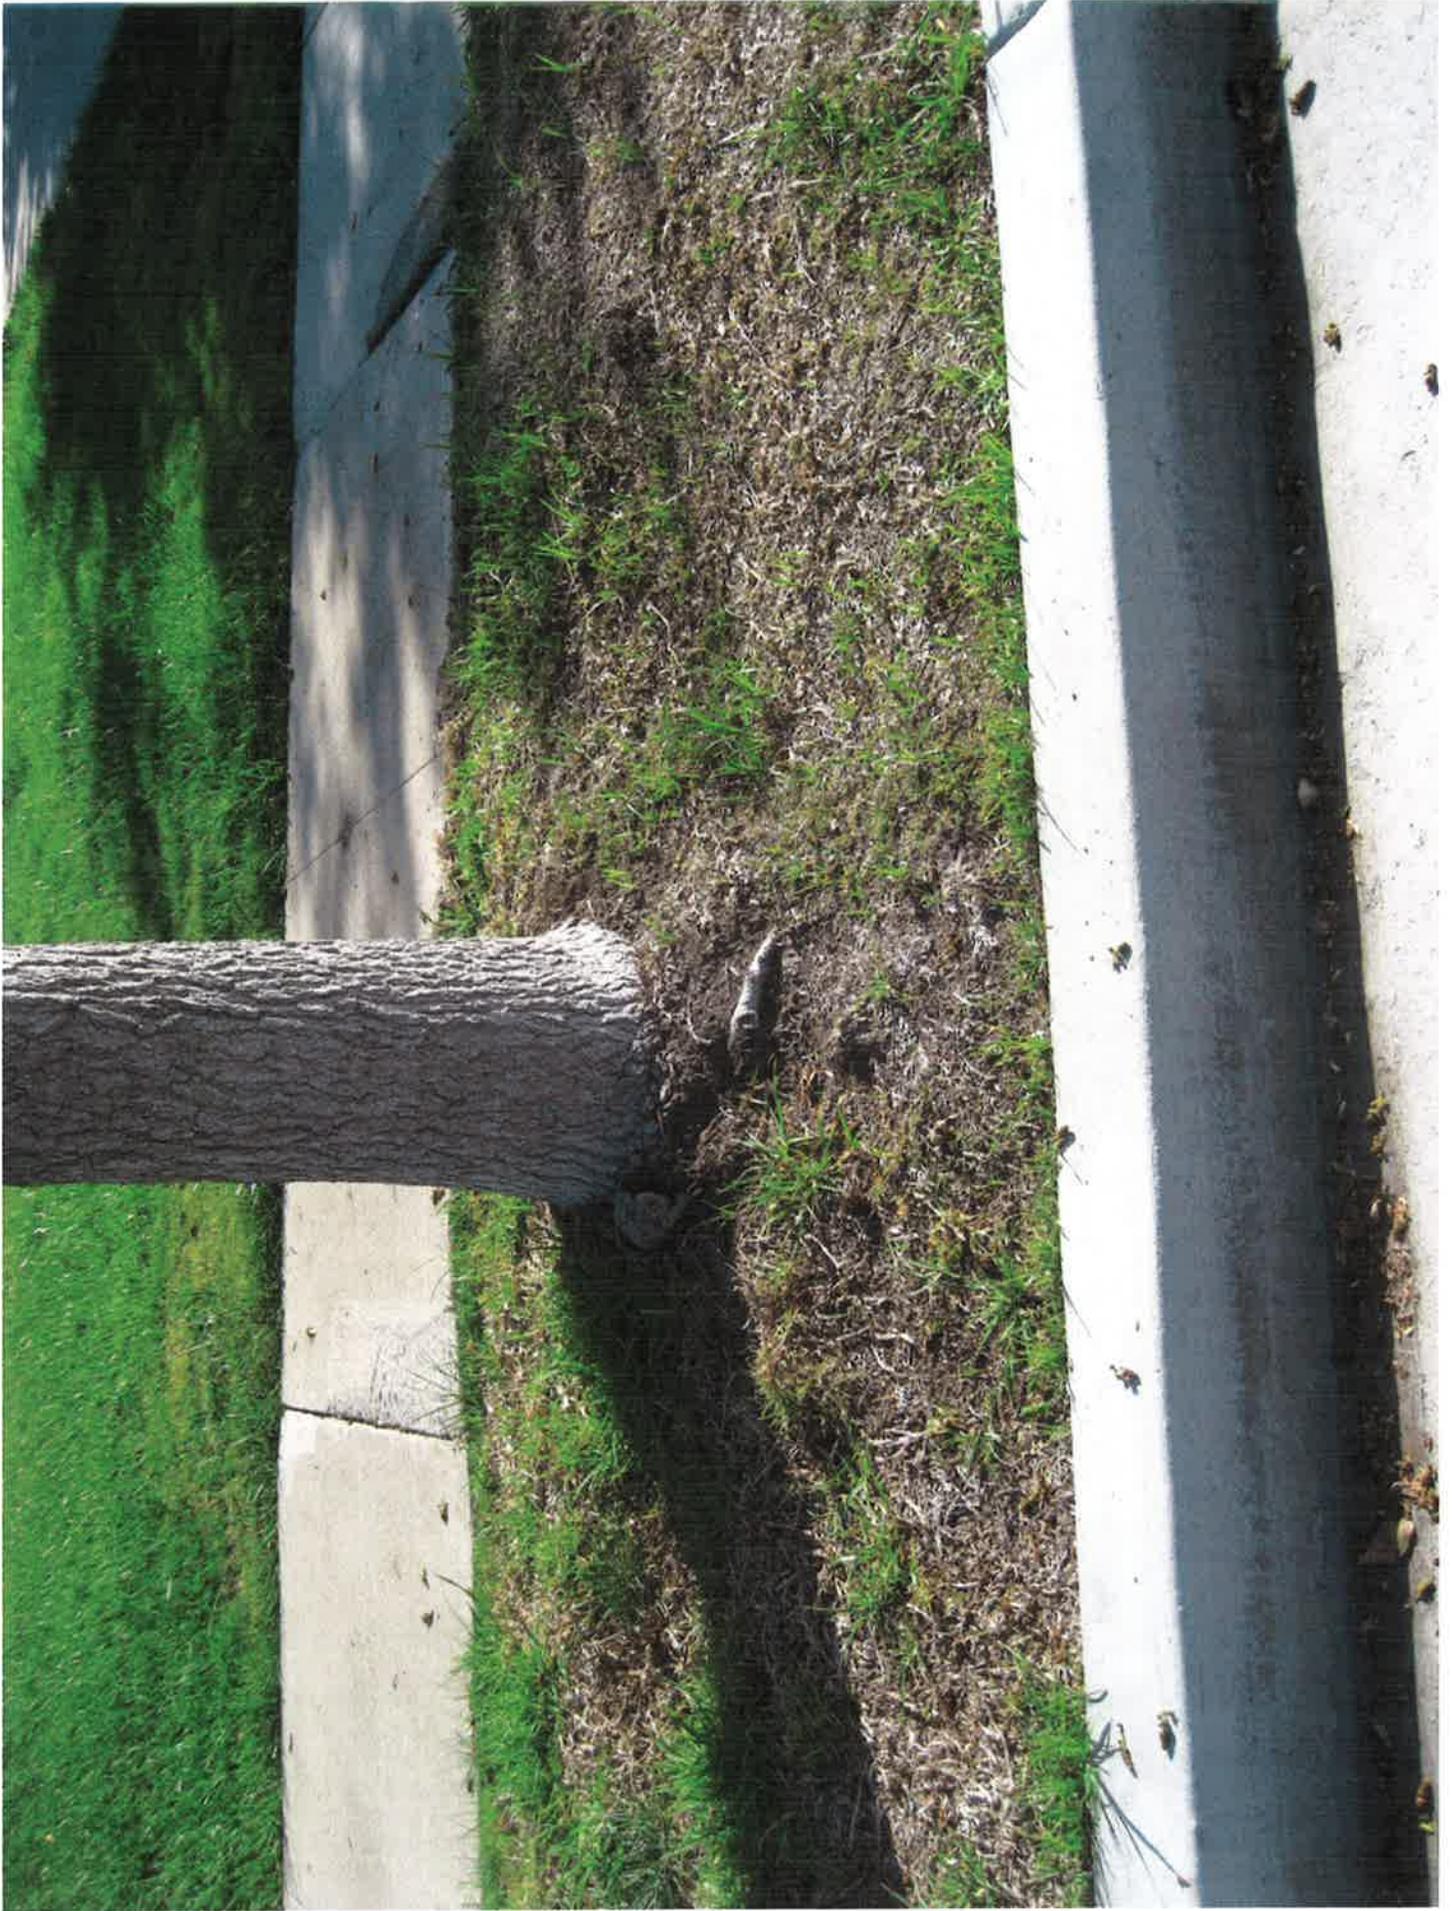
If Yes, describe damage: **Sidewalk raised and has been ramped and shaved. No trip hazard.**

Root Pruning Comments: **Tree appears to have been root pruned in the past, no record of root pruning in the database. No need to root prune.**
