FACILITY CONDITION ASSESSMENT

Police Substation
567 West 18th Street
Costa Mesa, CA 92627

171582.25R000-014.354

July 2, 2025

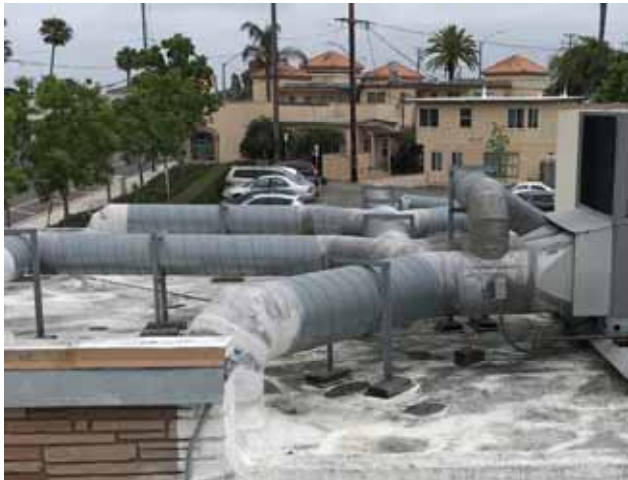
15 - HVAC SYSTEM

HVAC components consist of rooftop packaged units providing heating and cooling for the building. Some of the units were replaced recently and appear to be functioning well. Domestic hot water is provided via two electric water heaters and they are reported to be adequate for the facility's needs. Plumbing fixtures are in fair condition throughout the building.

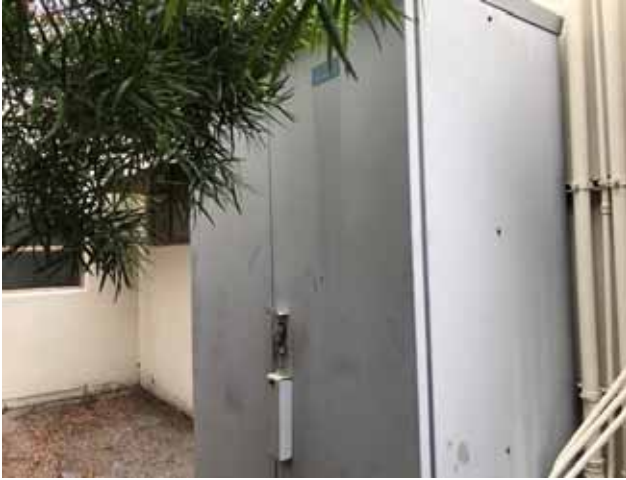
19 - SWITCHBOARD

Electrical System in Poor condition.

System is original and does not meet the demand, system upgrades is recommended. - AssetCALC ID: 9414064

Uniformat Code: D5030
Recommendation: **Replace in 2026**

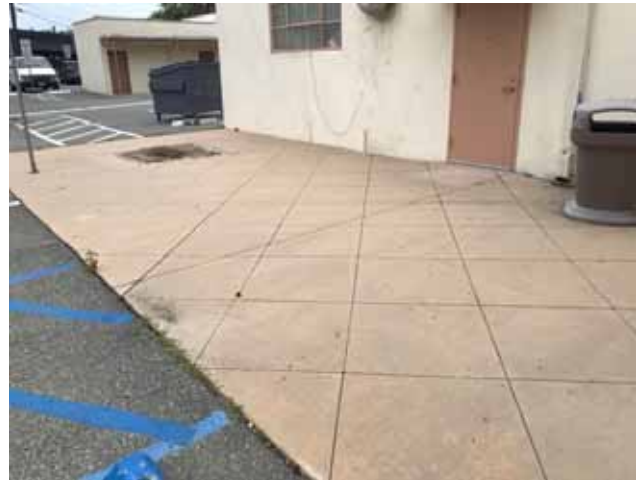
22 - SIDEWALK

The asphalt parking lot located at both sides of the building is in fair condition with isolated areas of potholes and alligator asphalt surface. The site is irrigated and contains planting beds with trees, shrubs, and various ground covers. Concrete sidewalks is in fair condition.
