# **PARKS AND RECREATION COMMISSION AGENDA REPORT**

MEETING DATE: JANUARY 23, 2014

**SUBJECT:** TREE REMOVAL REQUEST - YUKON AVENUE

**FROM:** PUBLIC SERVICES DEPARTMENT, MAINTENANCE SERVICES DIVISION

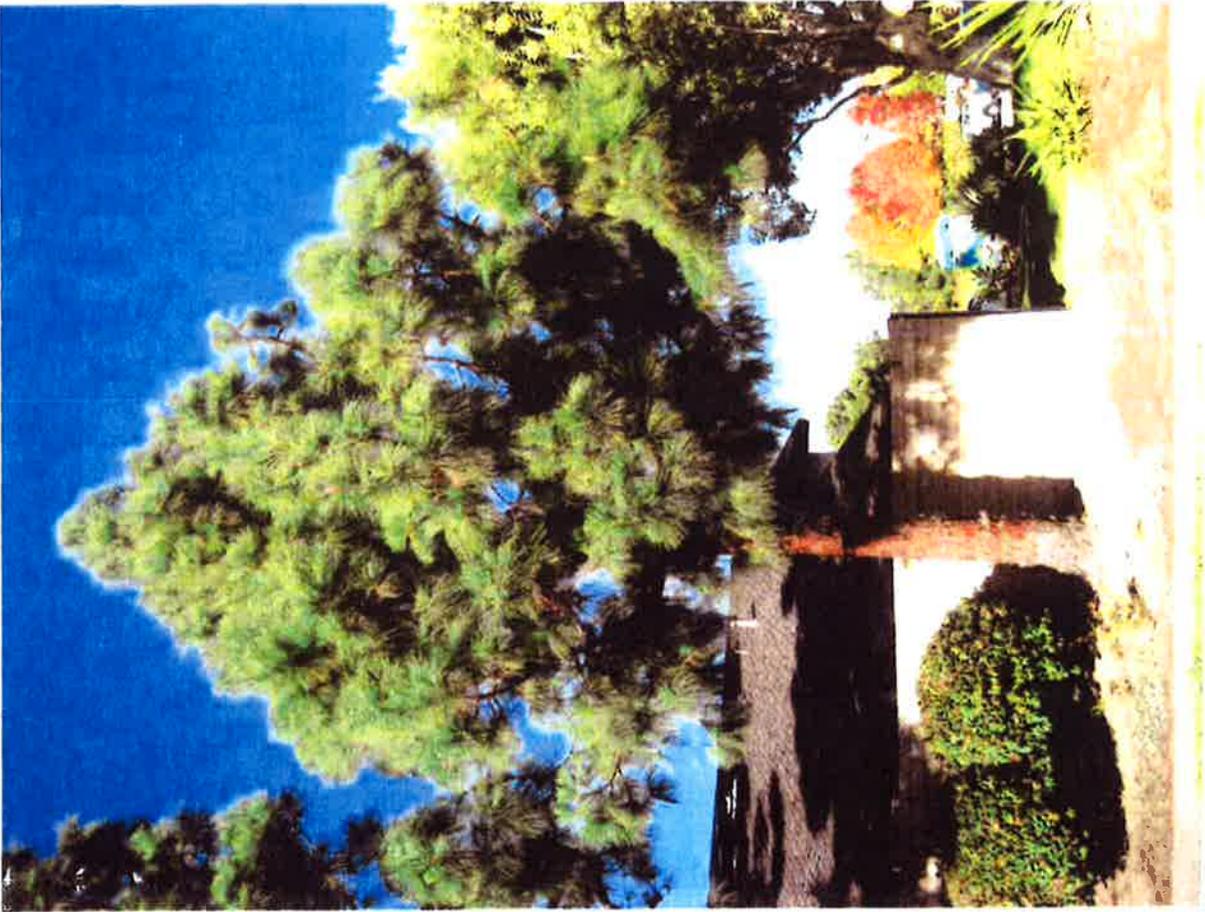
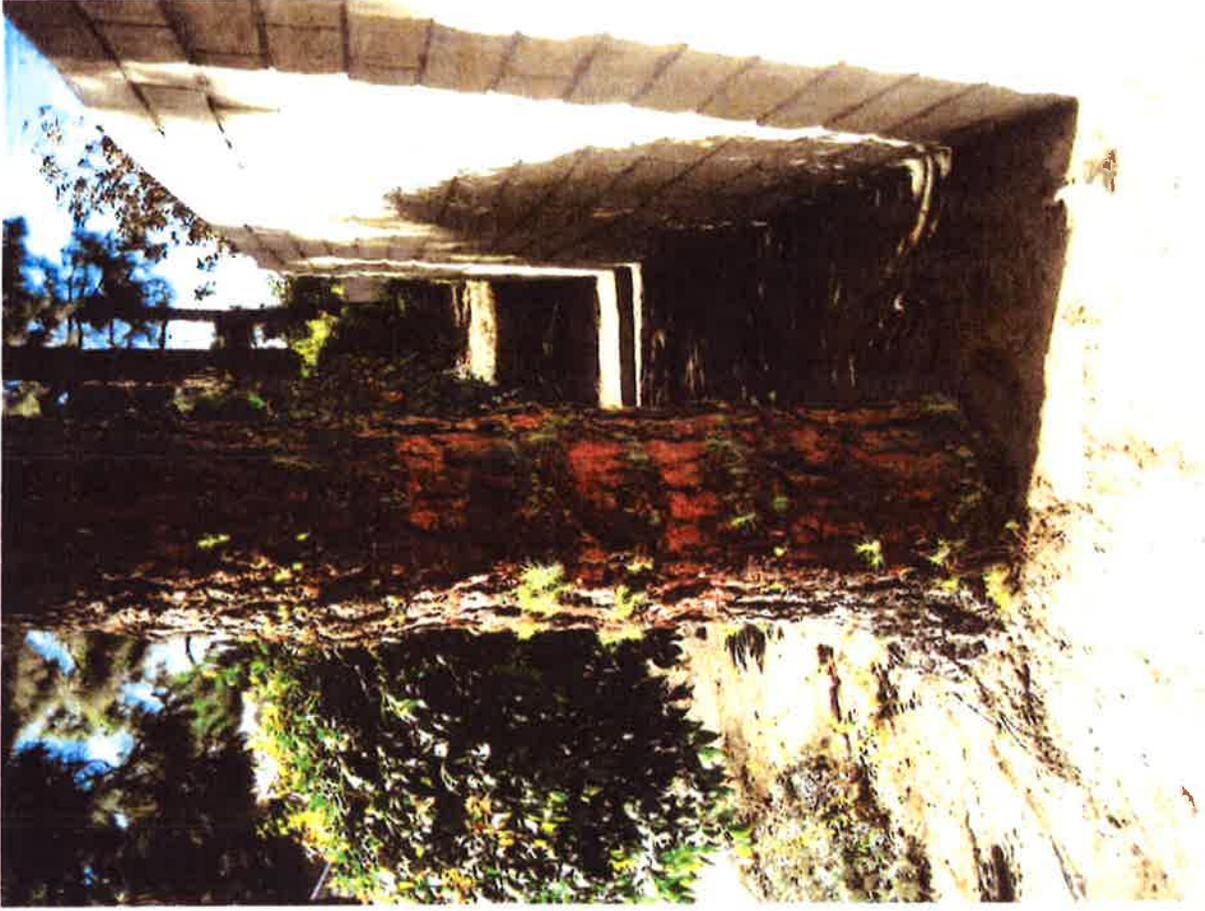
Yukon Avenue – Slope Tree #1

If Yes, describe damage: **Cracked sidewalk.**

Root Pruning Comments: **Root pruning will mitigate hardscape damage.**

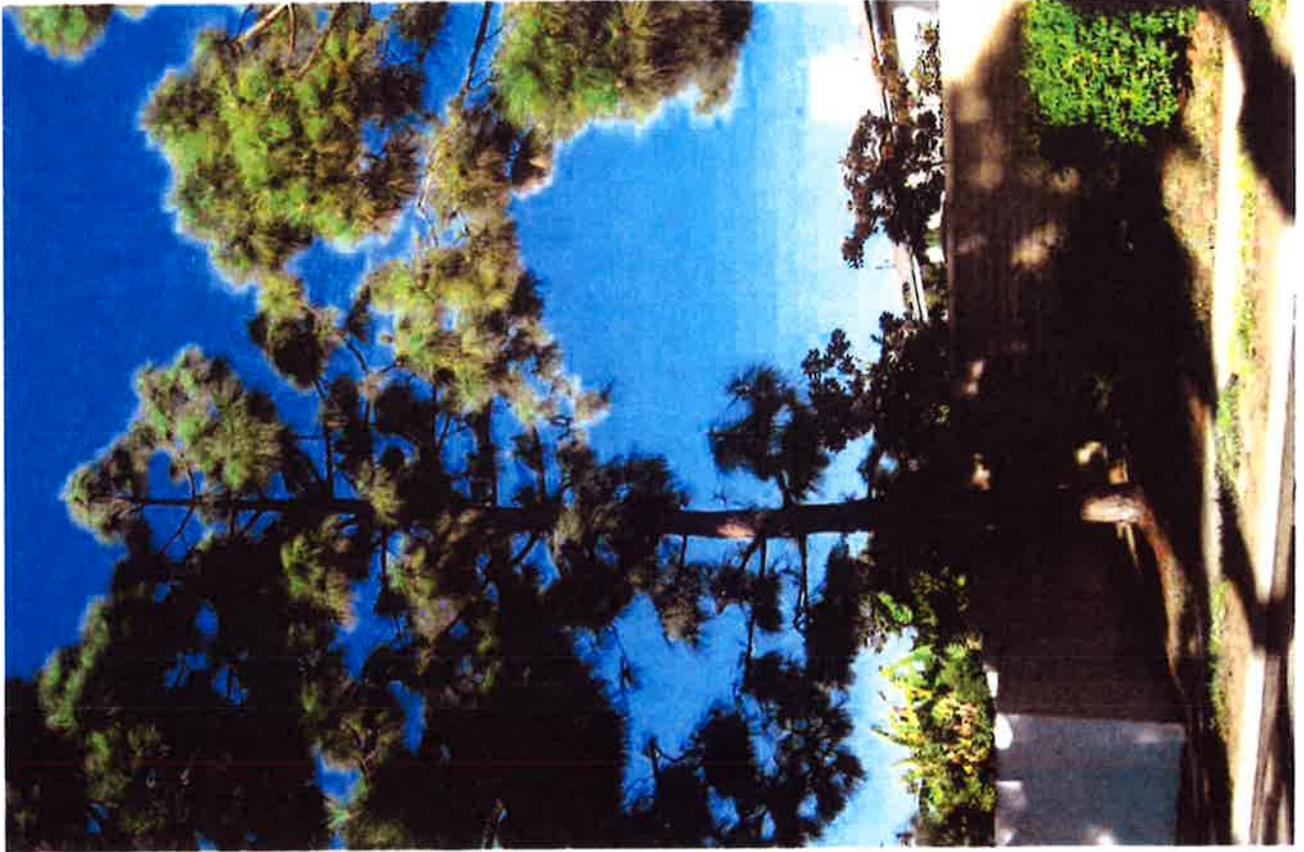
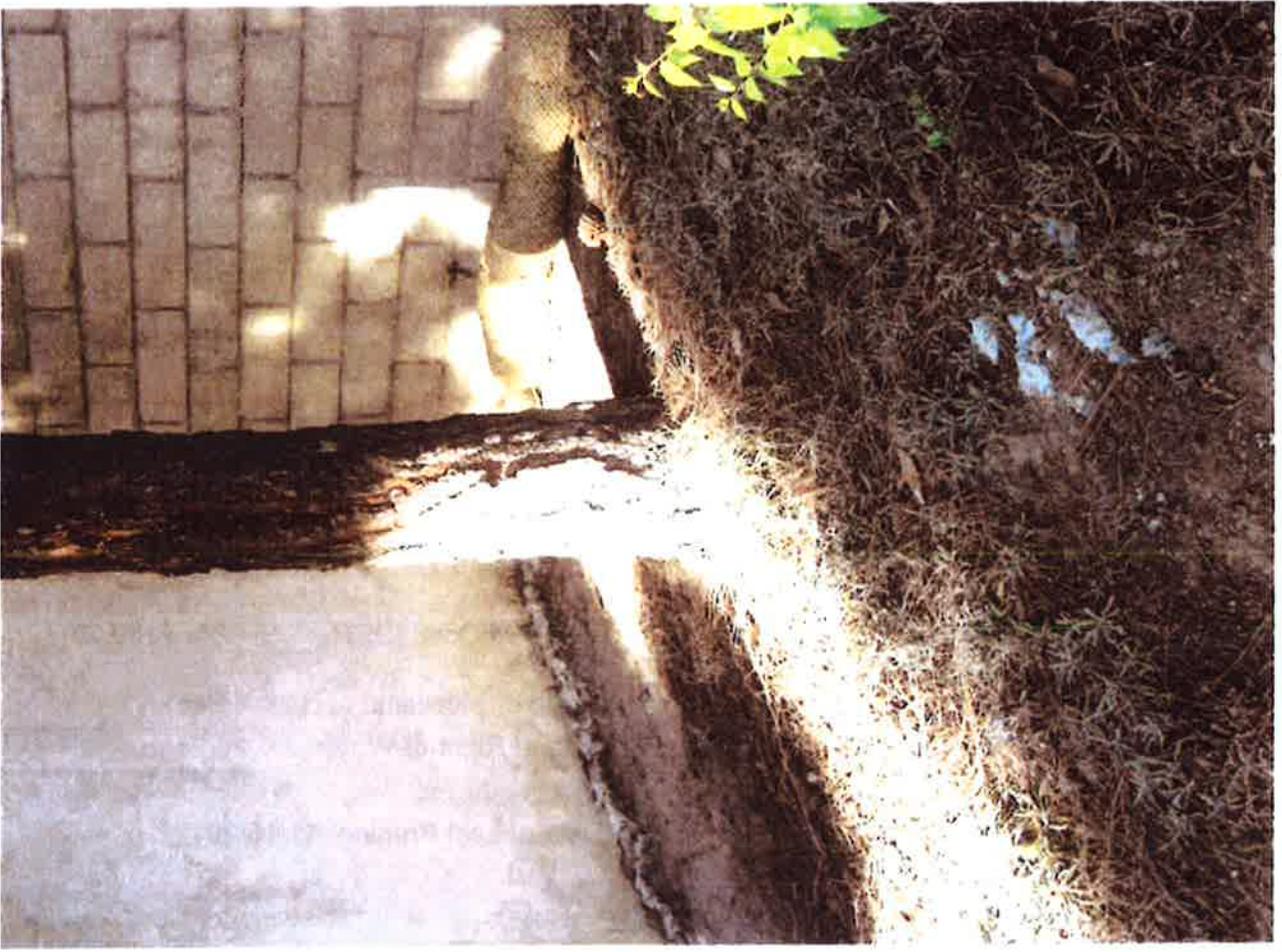
**Yukon Avenue – Slope Tree #4**

If Yes, describe damage: **Lifted sidewalk.**

Root Pruning Comments: **Root pruning will mitigate hardscape damage.**

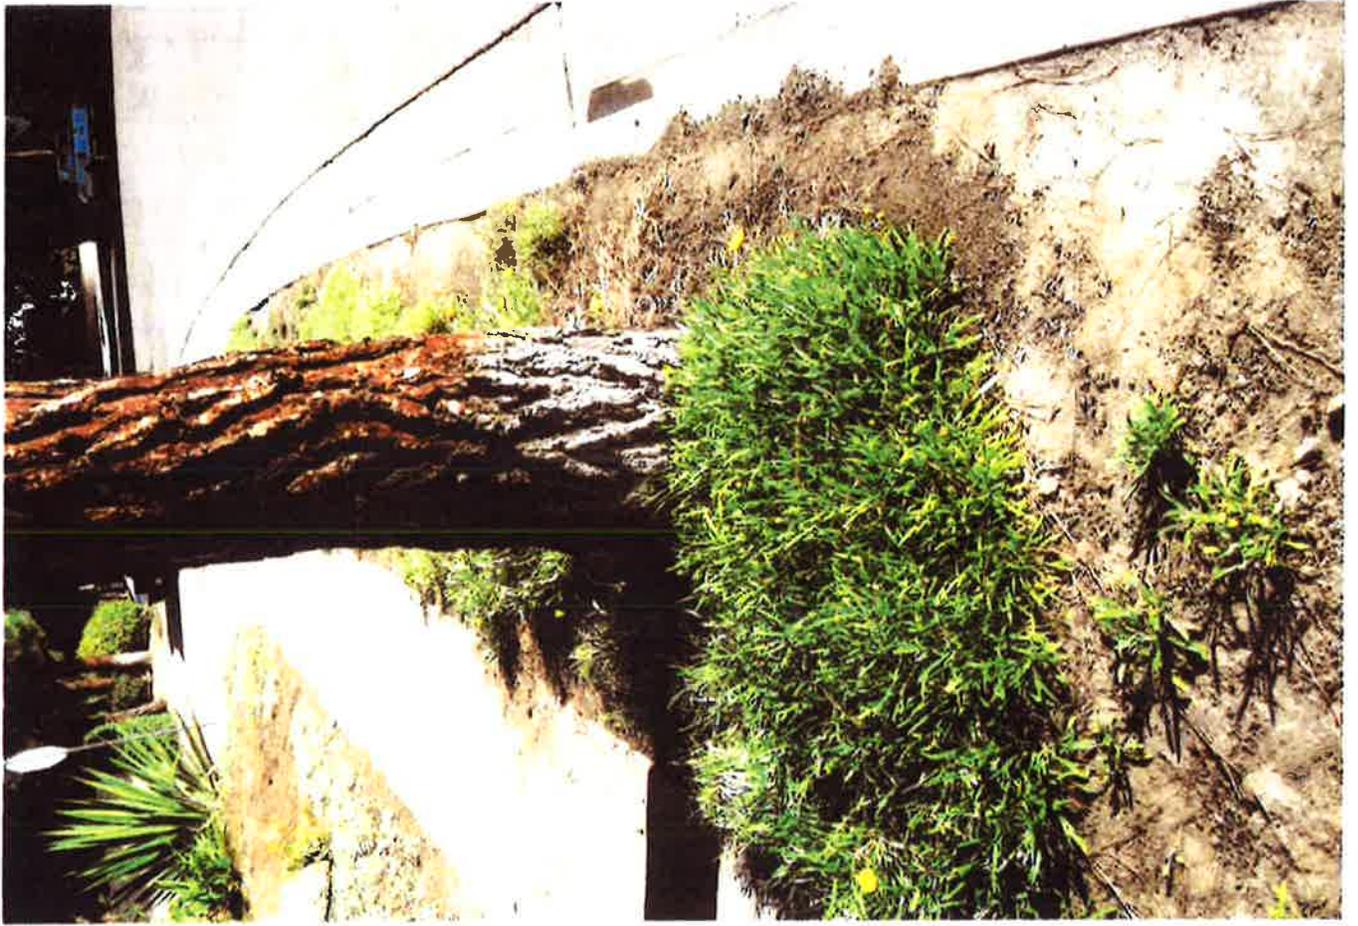
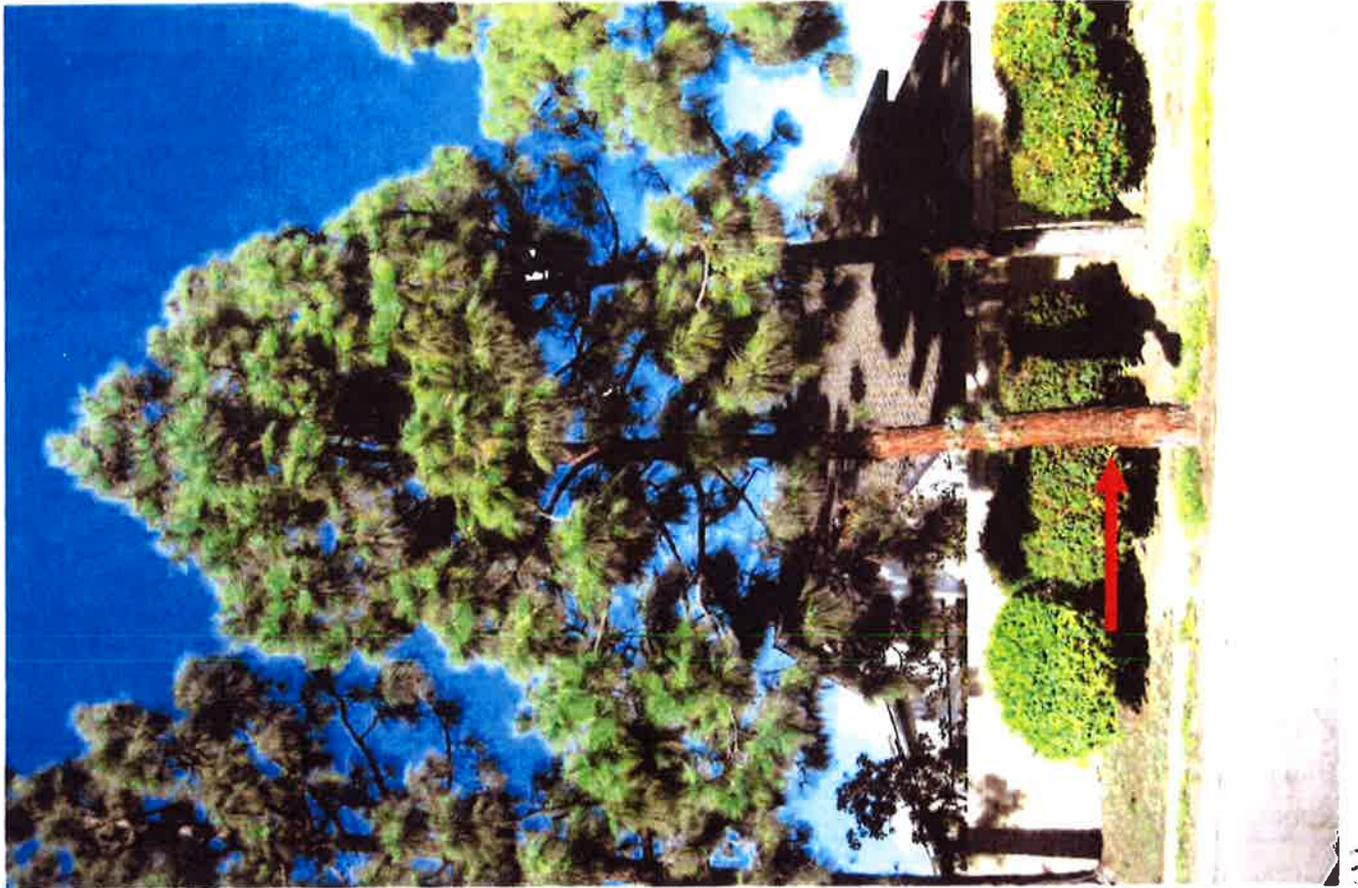
Yukon Avenue – Tree F1

Comments: **Extensive damage to curb & gutter and sidewalk would be required to box the tree.  
Estimated value in Arbor Access is \$4,890.00**

If Yes, describe damage: Cracked curb and cracked sidewalk.

Root Pruning Comments: **Root pruning will mitigate hardscape damage.**

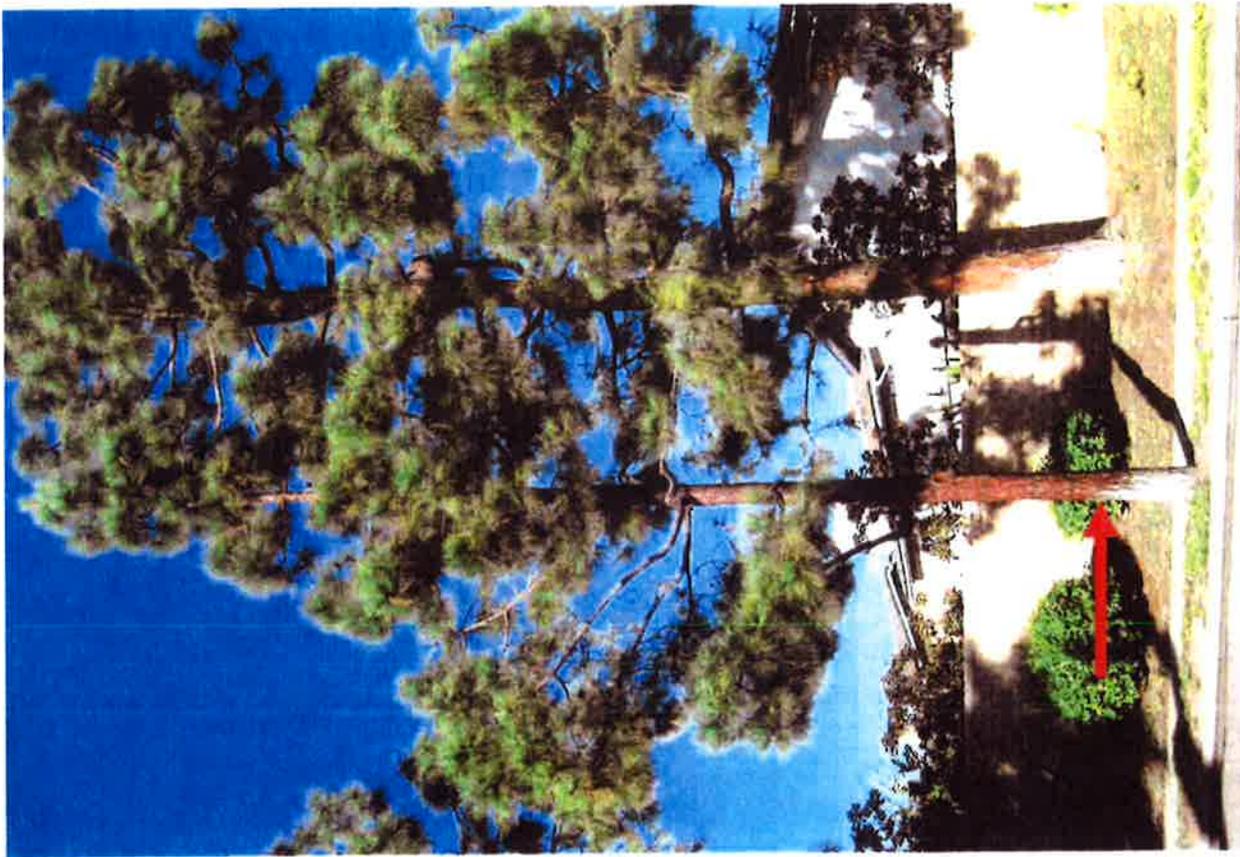
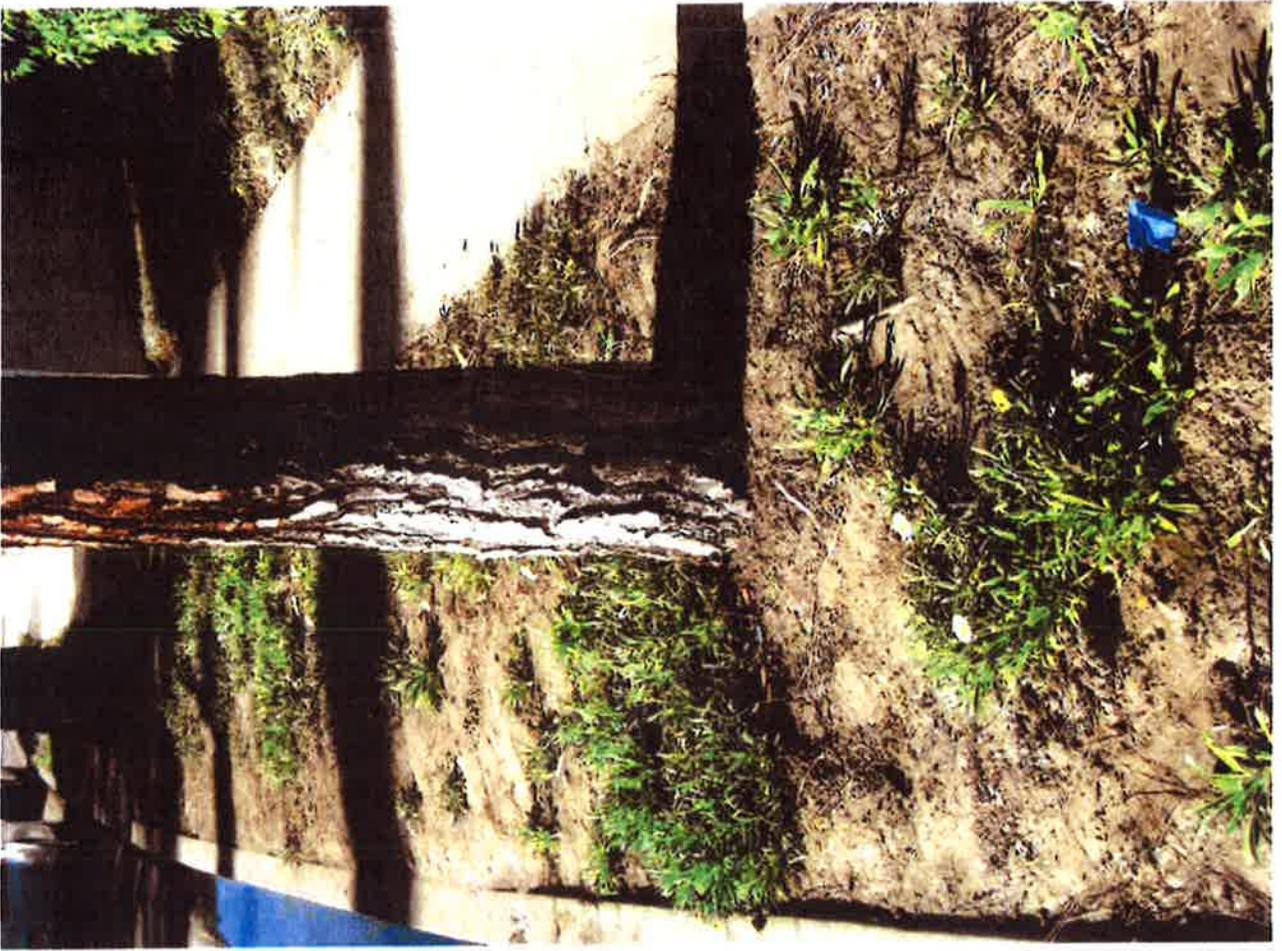
Yukon Avenue – Tree F2

Comments: **Extensive damage to curb & gutter and sidewalk would be required to box the tree. Estimated value in Arbor Access is \$4,890.00**

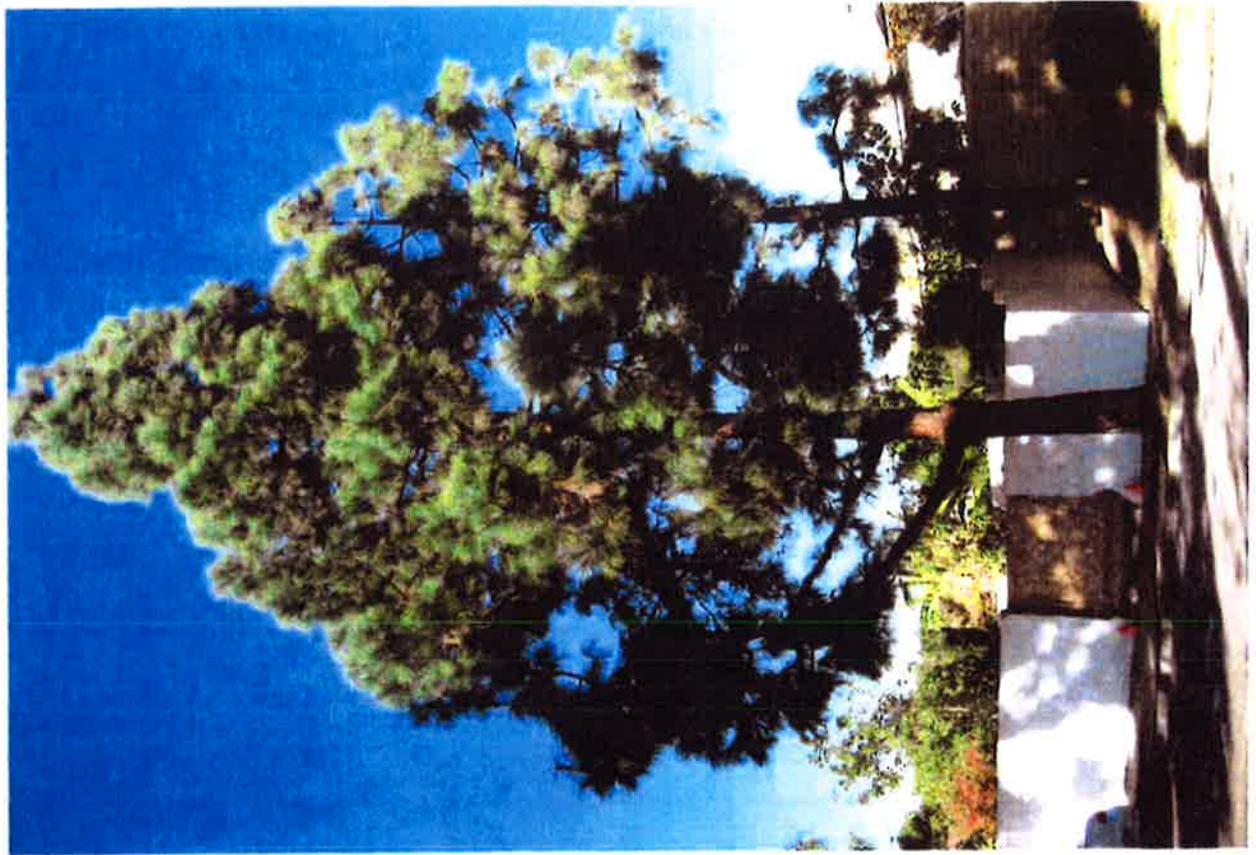
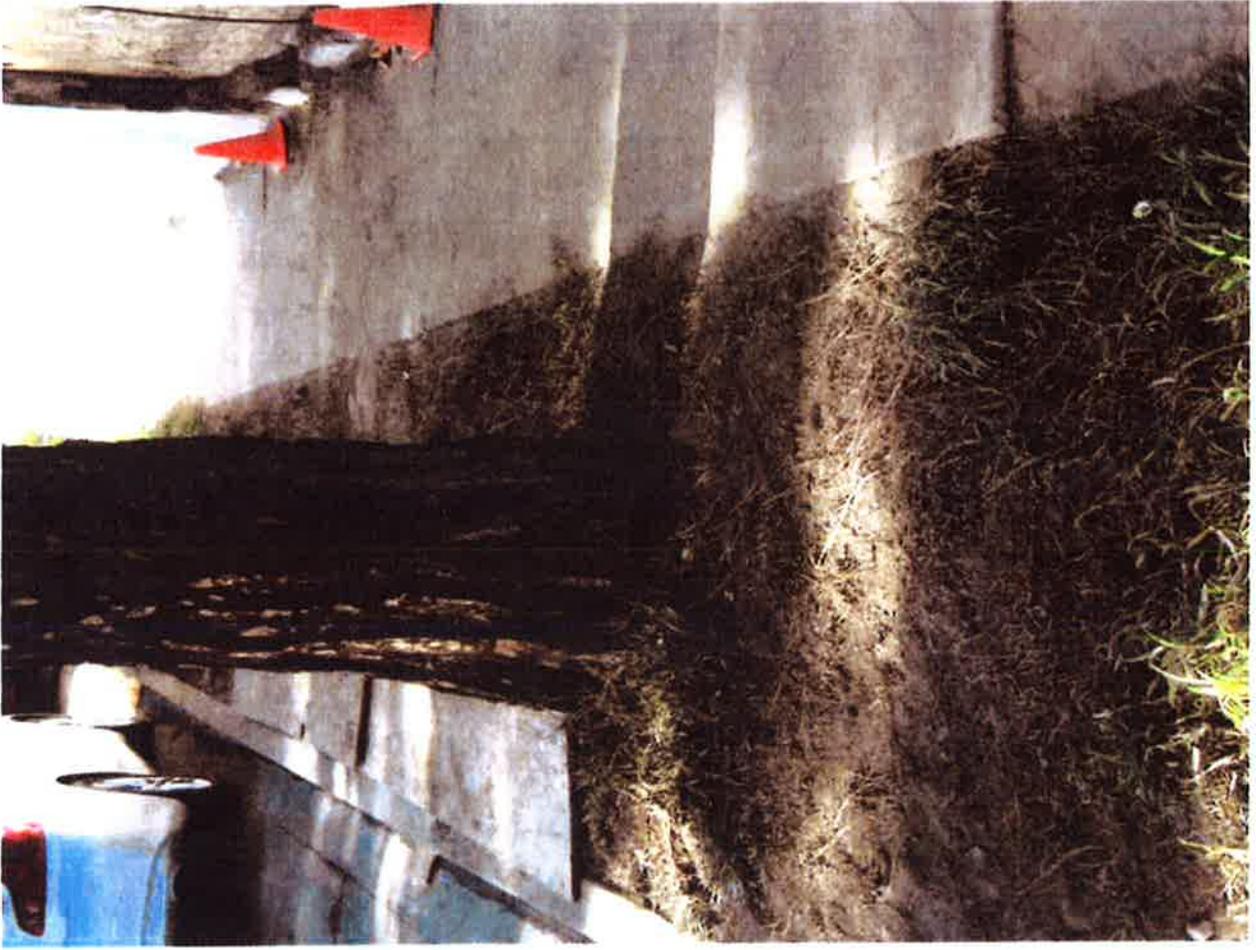
Yukon Avenue – Tree F3

Comments: **Extensive damage to curb & gutter and sidewalk would be required to box the tree. Estimated value in Arbor Access is \$9,110.00**

If Yes, describe damage: **Cracked sidewalk and lifted panel.**

Root Pruning Comments: **Root pruning will mitigate lifting and cracking.**

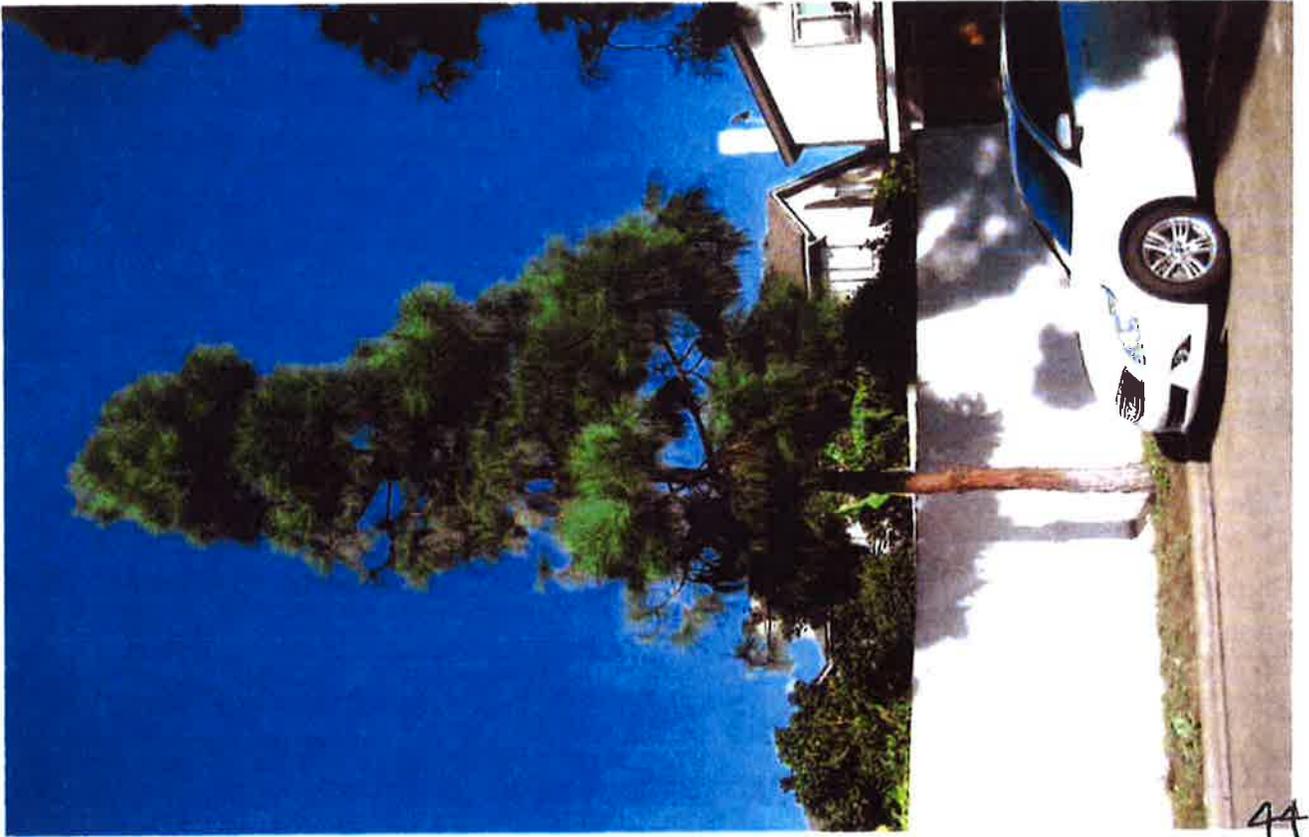
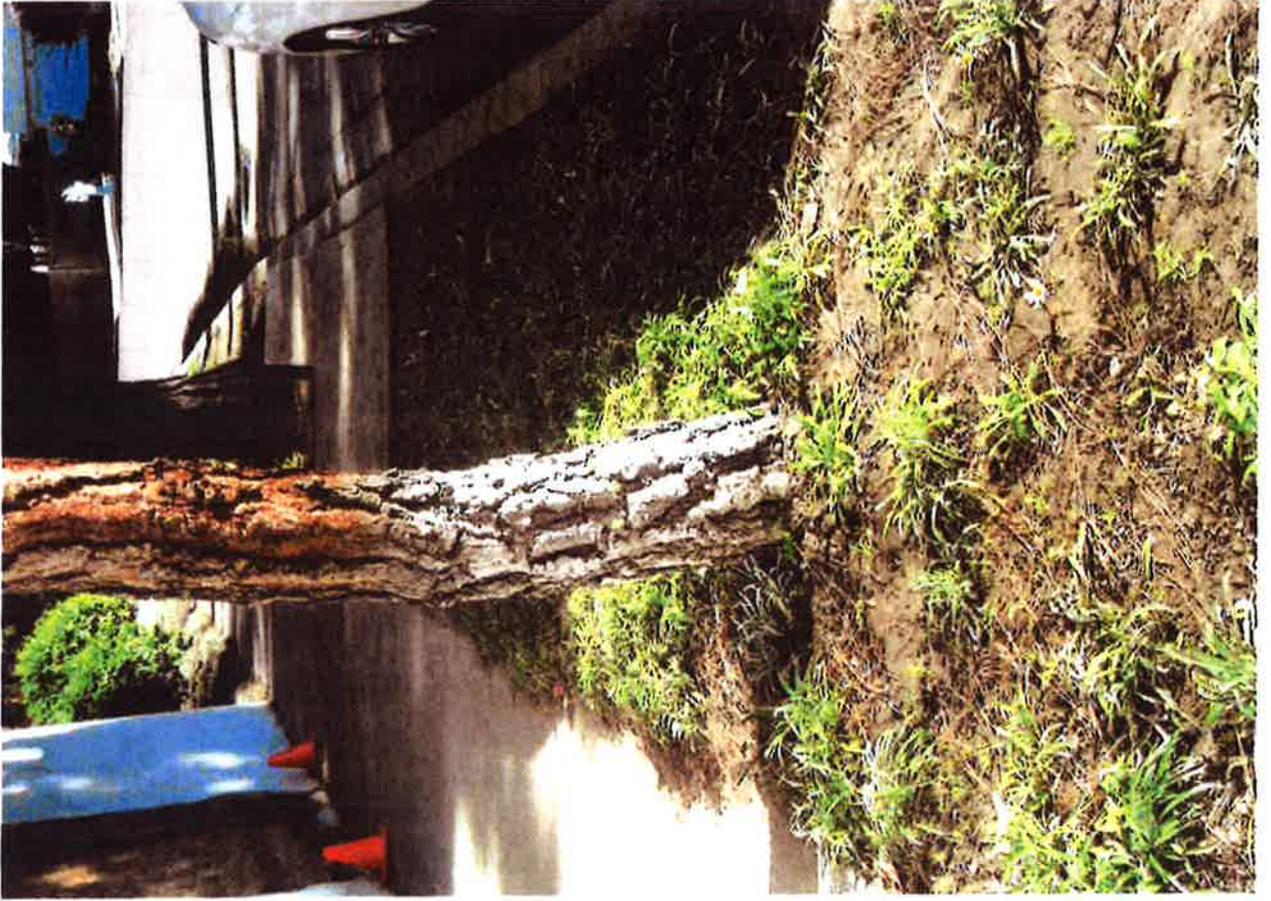
Yukon Avenue – Tree F4

Comments: **Extensive damage to curb & gutter and sidewalk would be required to box the tree.  
Estimated value in Arbor Access is \$4,890.00**

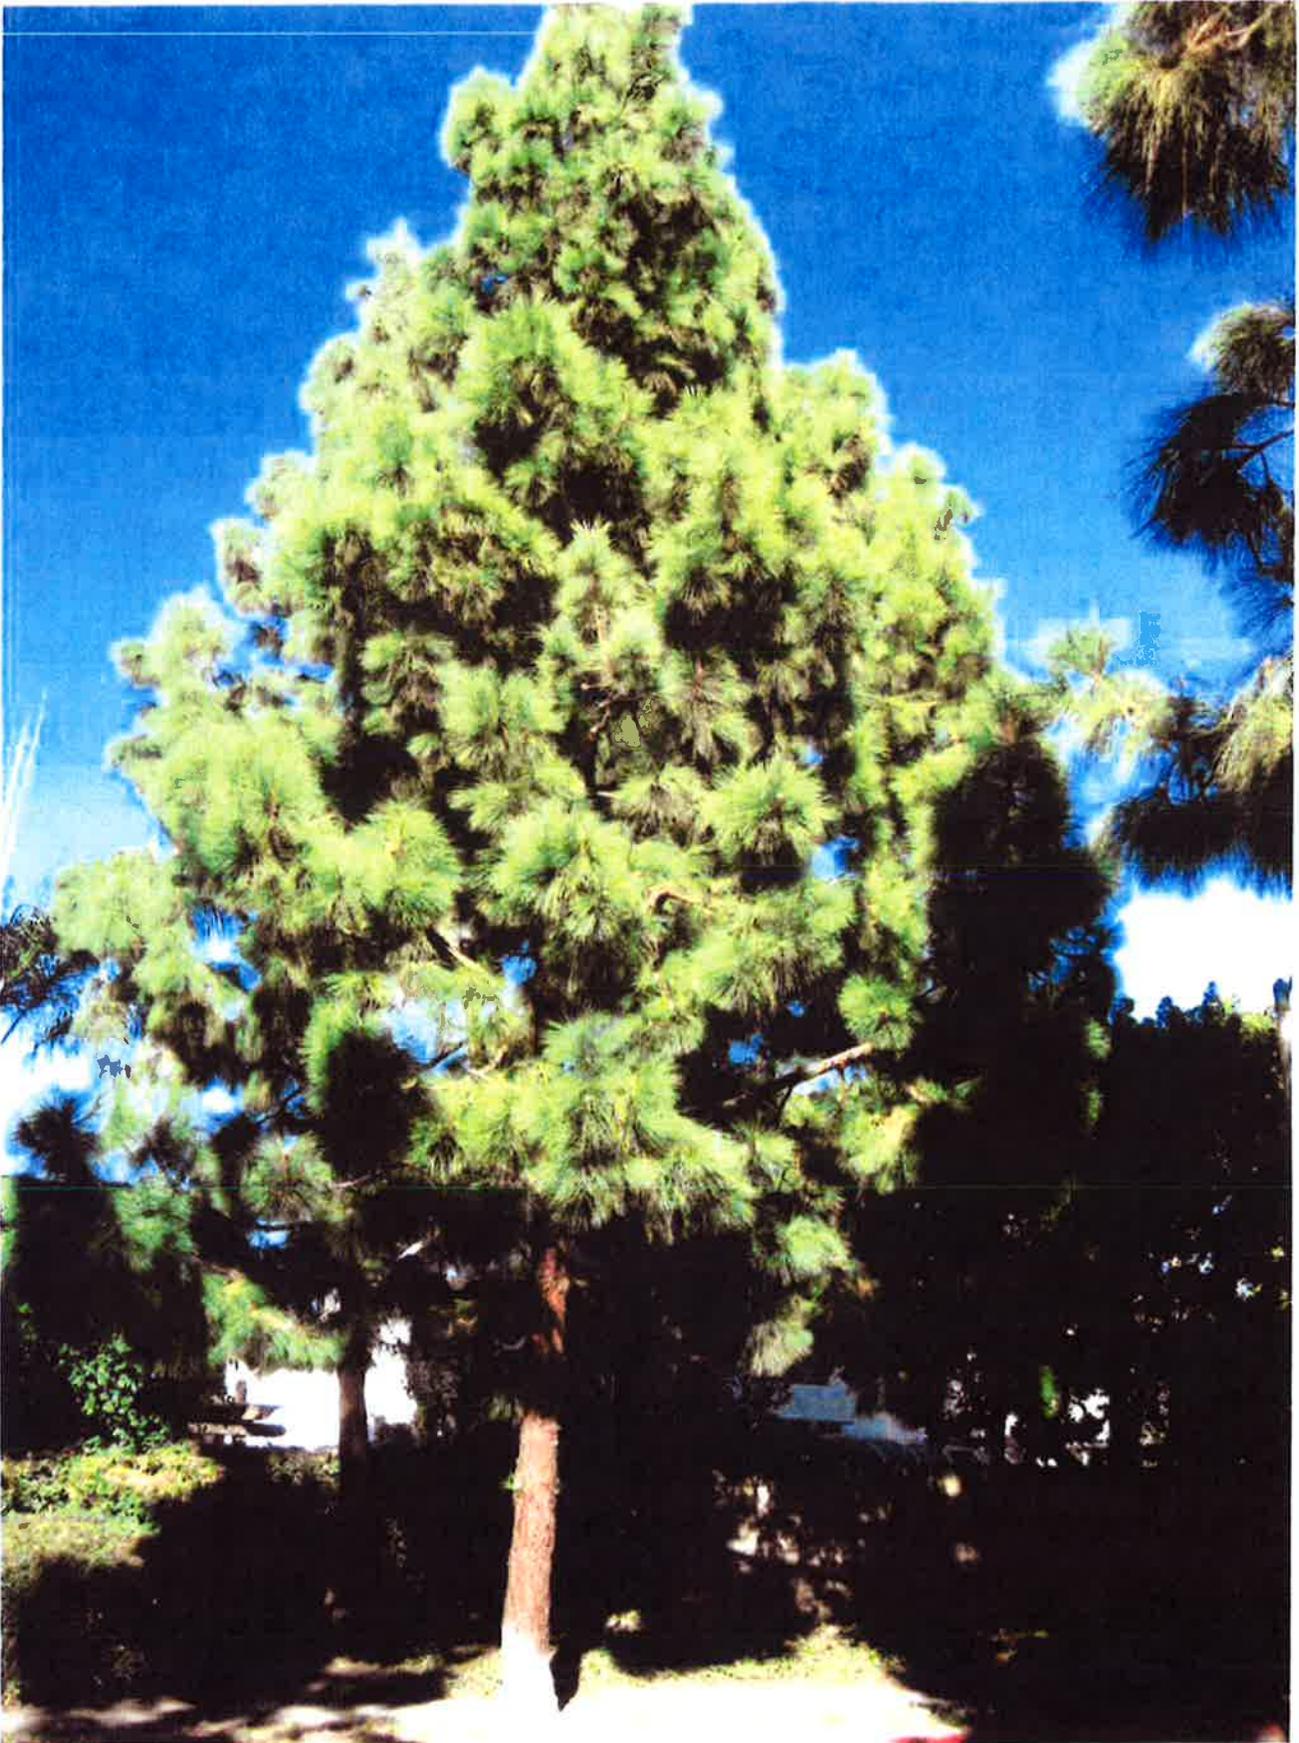
Yukon Avenue – Tree F5

Comments: **Tree is too large to move. Extensive damage to curb & gutter and sidewalk would be required to box the tree. Estimated value in Arbor Access is \$4,890.00**

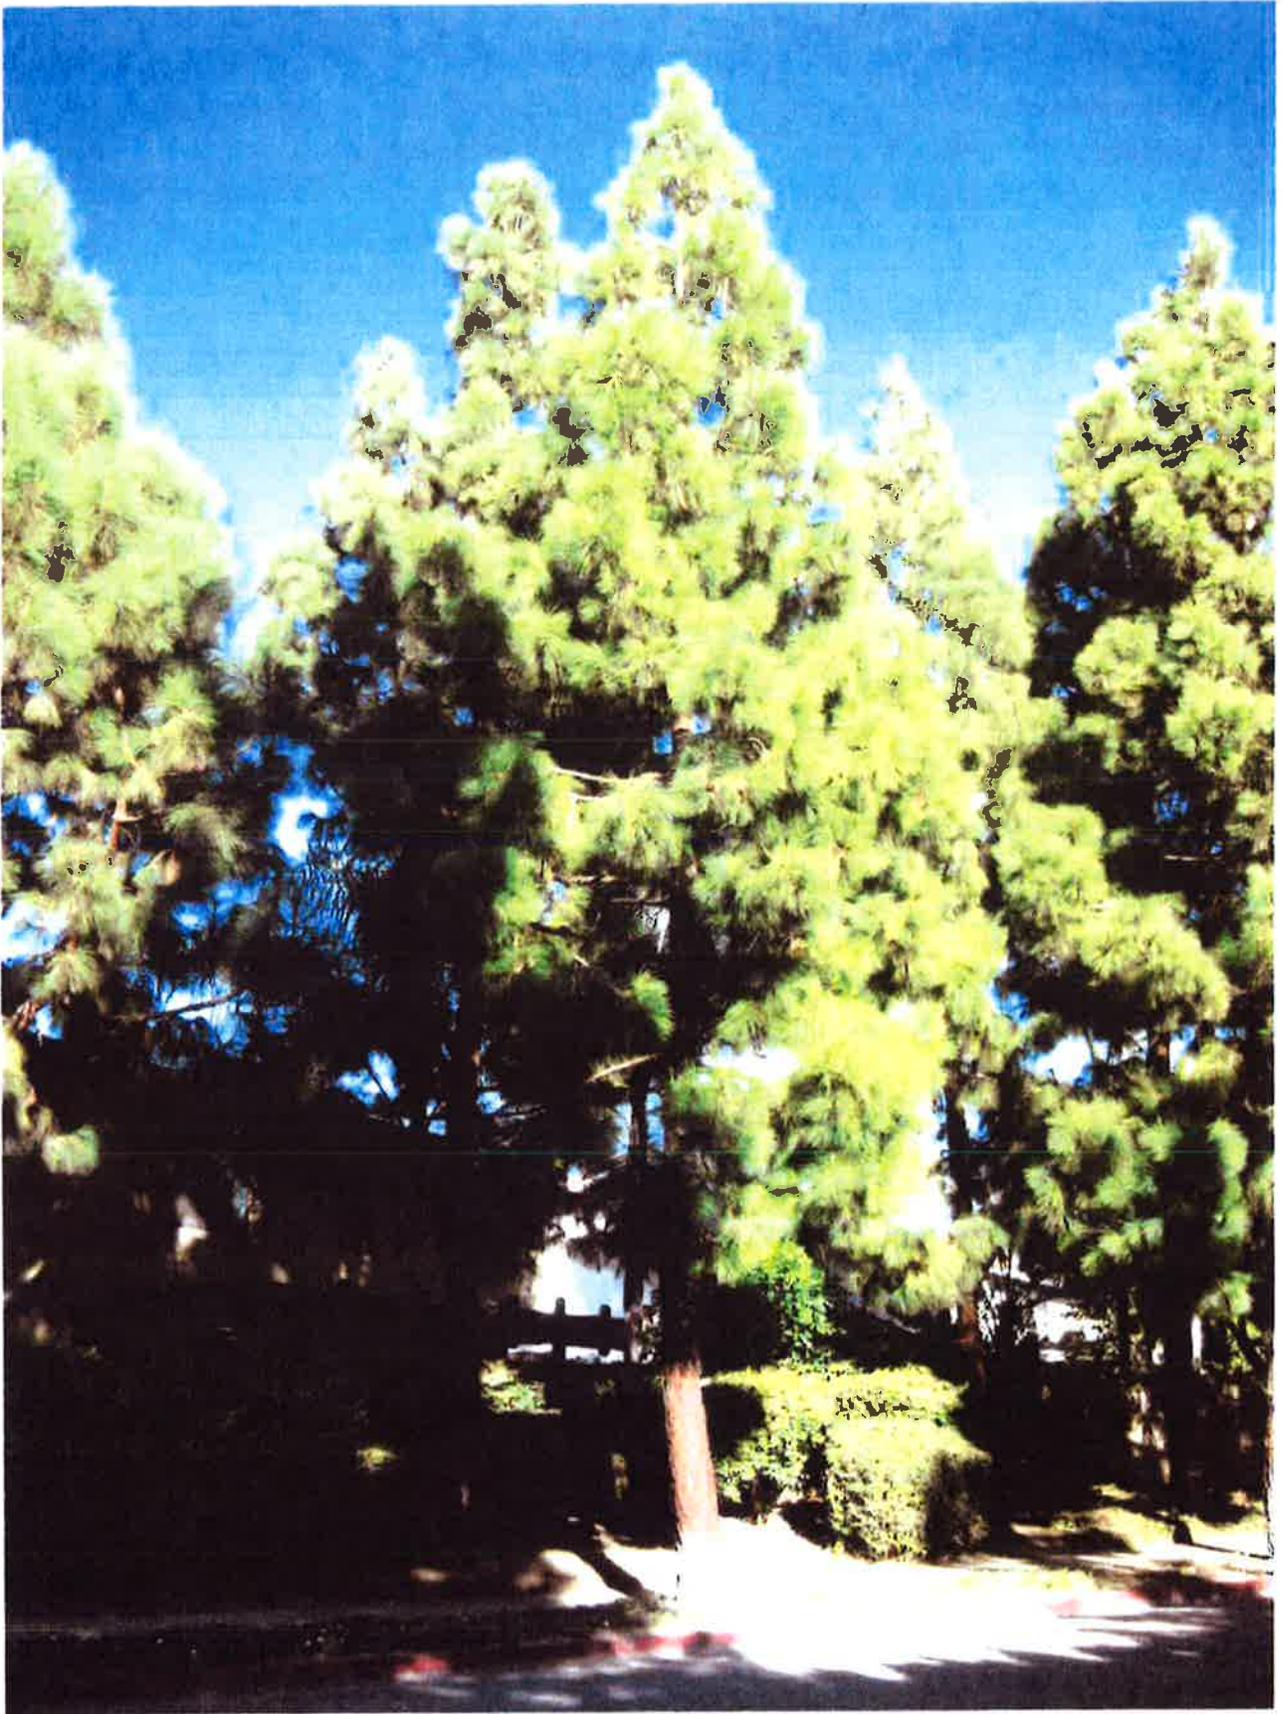
Yukon Avenue – Tree F6

Comments: **Tree is too large to move. Extensive damage to curb & gutter and sidewalk would be required to box the tree. Estimated value in Arbor Access is \$4,890.00**

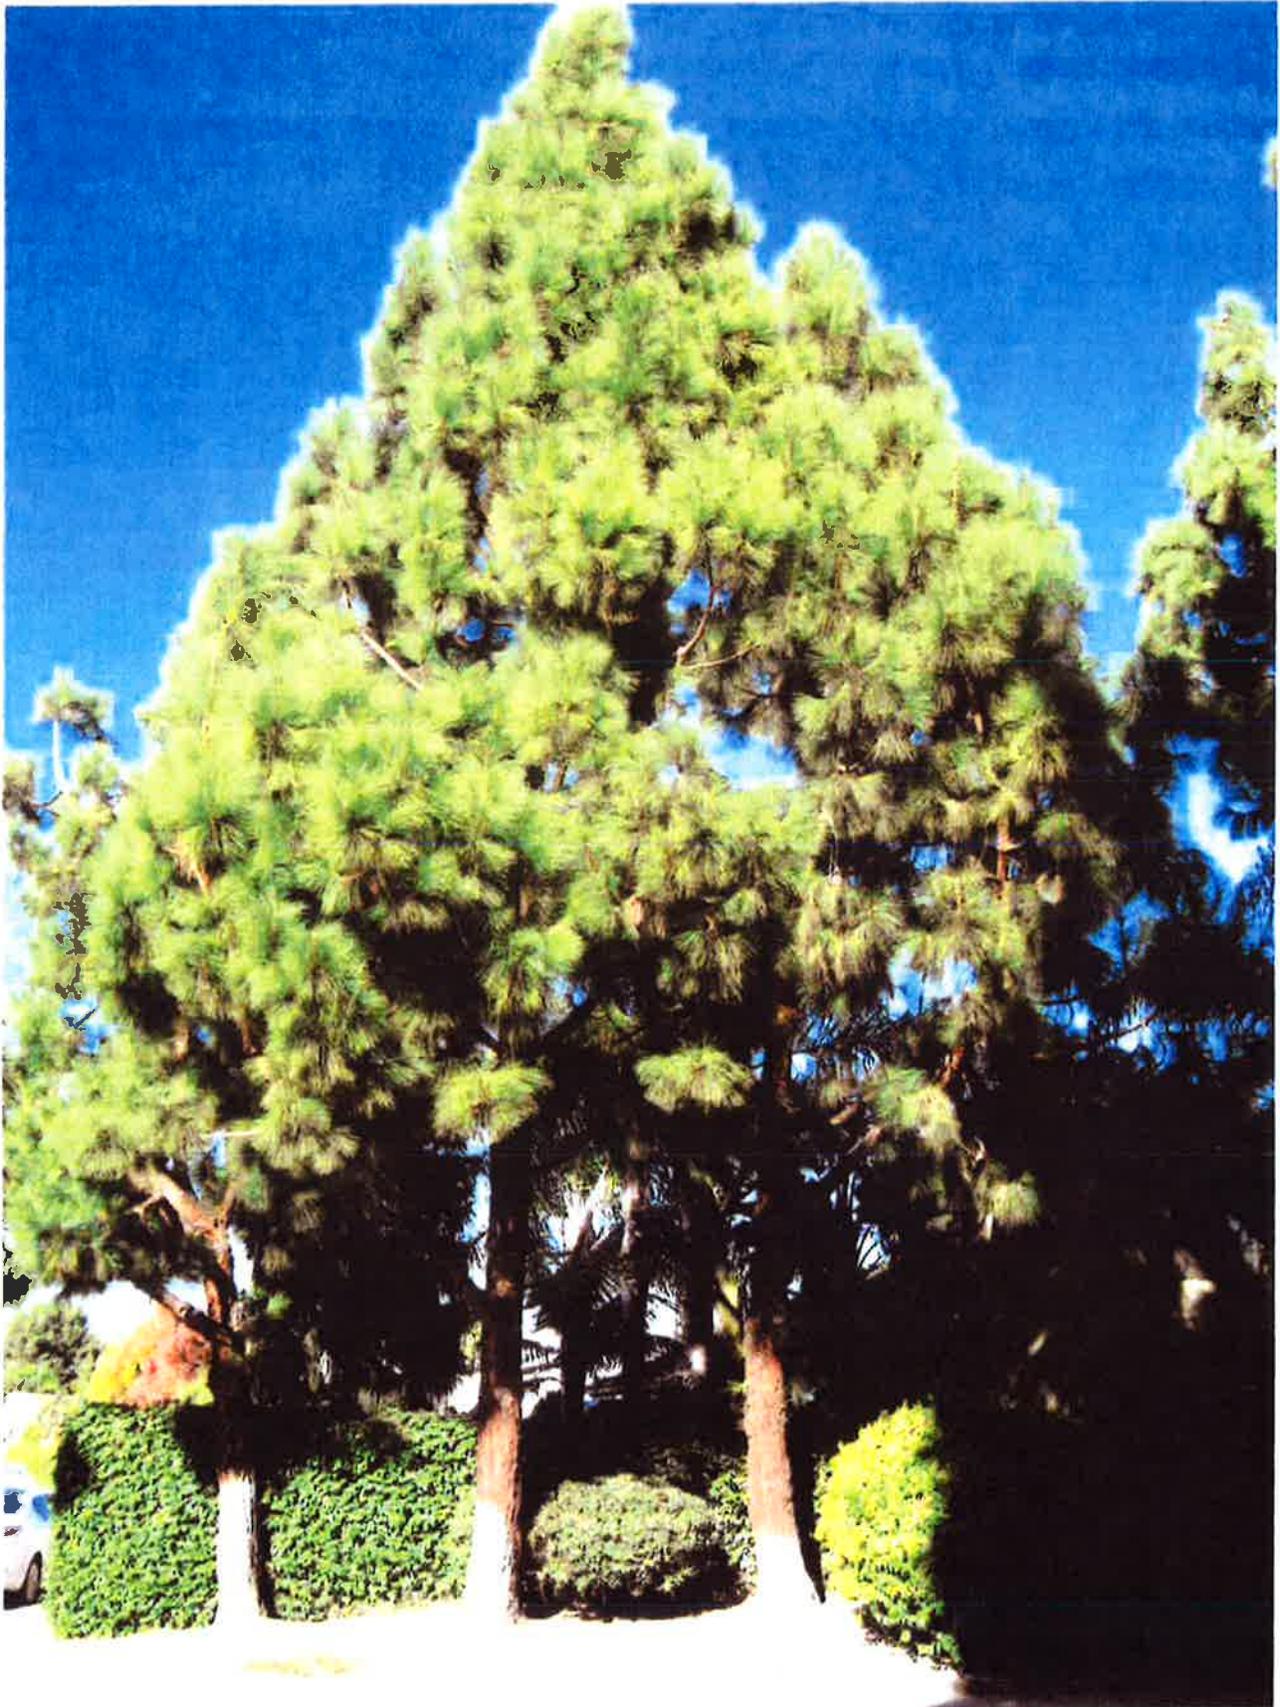
**Yukon Avenue – Slope Tree #12, #13 & #14**

If Yes, describe damage: **Lifting of sidewalk.**

If Yes, describe damage: **Lifting of sidewalk. Roots and trunk of the tree is cracking the wall.**

Root Pruning Comments: **Root pruning on the south side of the tree will mitigate lifting of the sidewalk. There is no way to root prune the tree to mitigate cracking of the wall.**

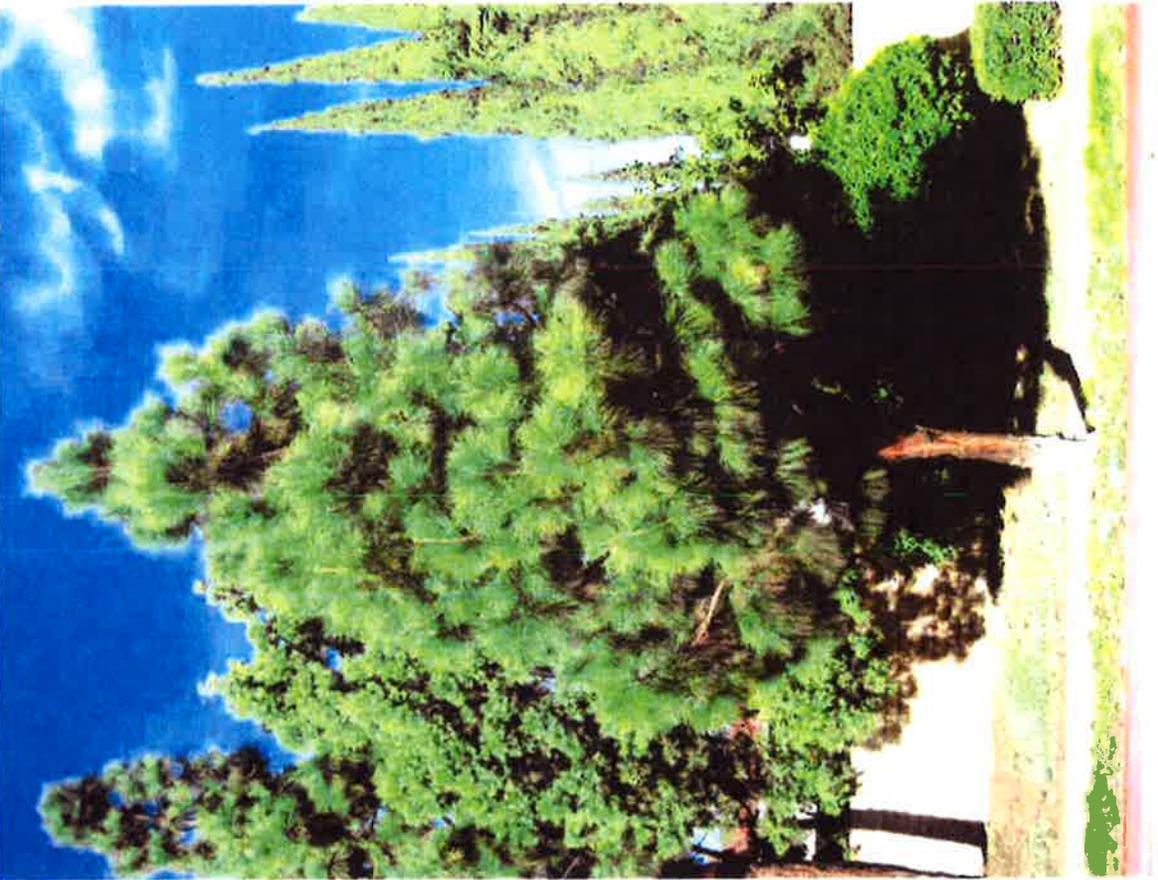
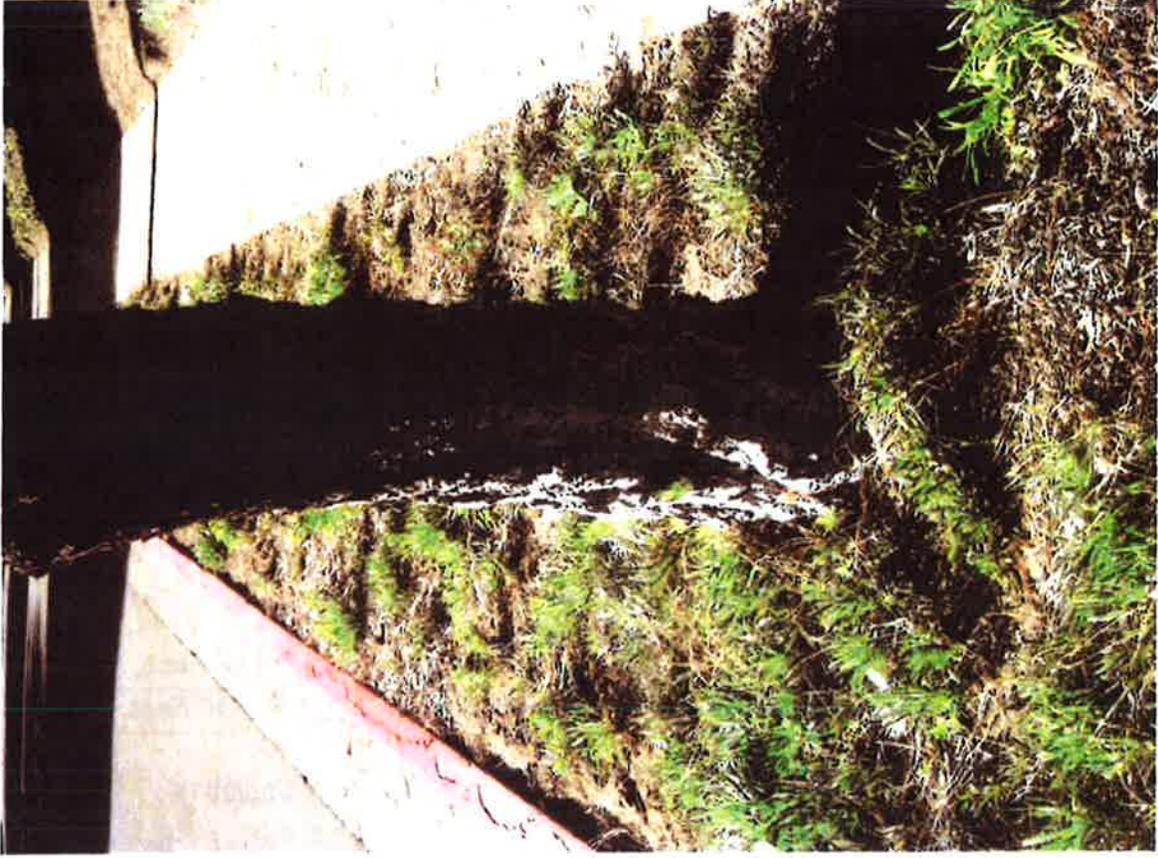
# Yukon Avenue – Tree F2

Comments: **Extensive damage to curb & gutter and sidewalk would be required to box the tree.  
Estimated value in Arbor Access is \$4,890.00**

If Yes, describe damage: **Slight lifting of the sidewalk.**
