# **PARKS AND RECREATION COMMISSION AGENDA REPORT**

MEETING DATE: JANUARY 23, 2014

**SUBJECT:** TREE REMOVAL REQUEST - YUKON AVENUE

**FROM:** PUBLIC SERVICES DEPARTMENT, MAINTENANCE SERVICES DIVISION

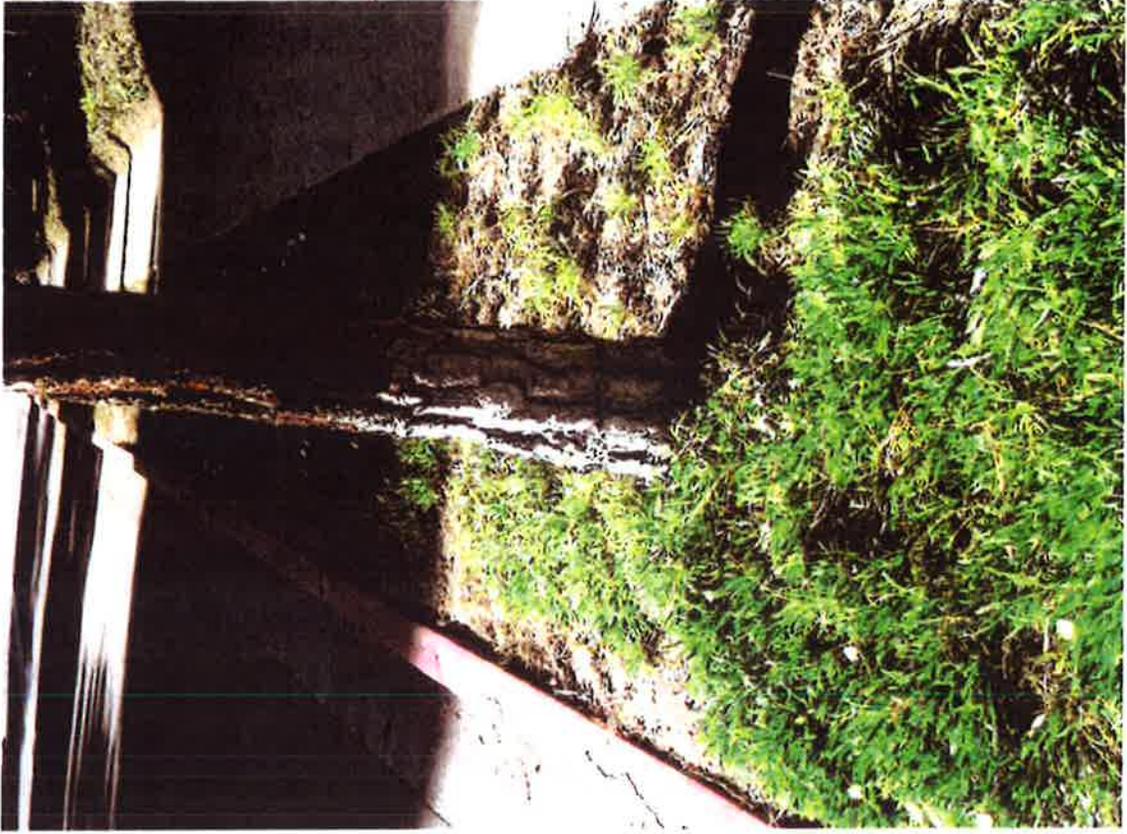
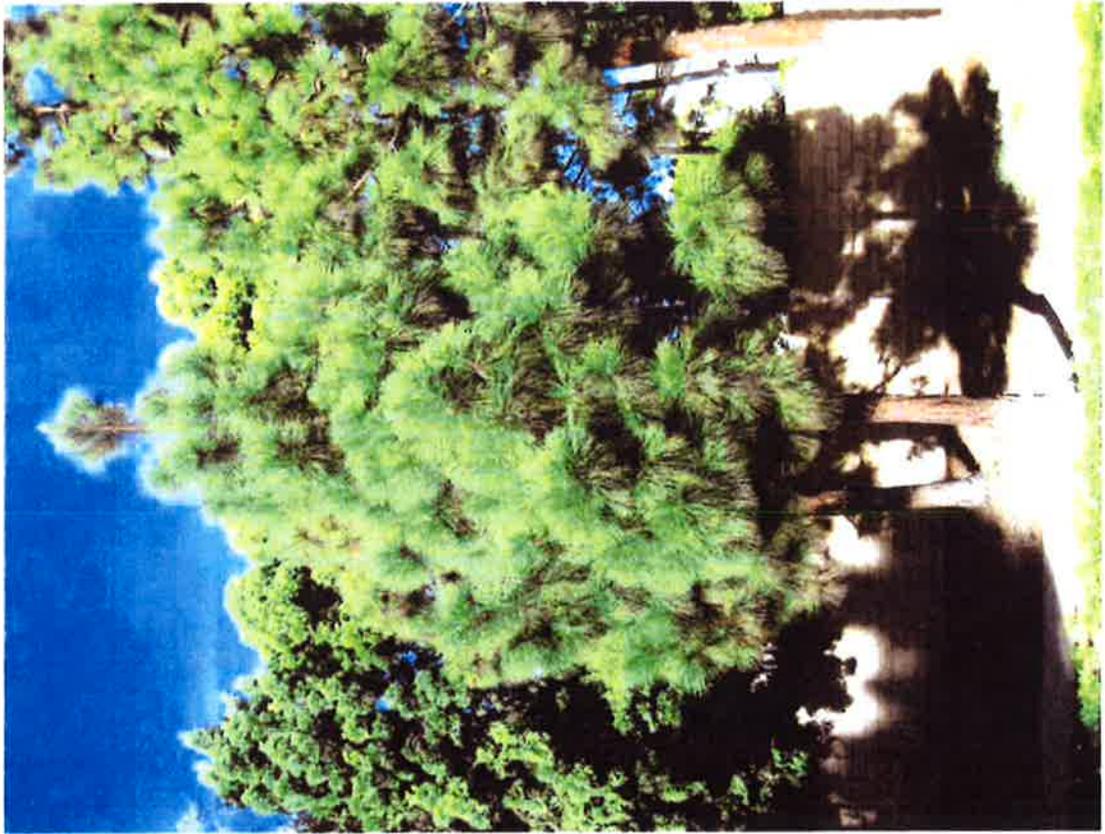
# Yukon Avenue – Tree F3

Comments: **Extensive damage to curb & gutter and sidewalk would be required to box the tree. Estimated value in Arbor Access is \$4,890.00**
