PARKS AND RECREATION COMMISSION AGENDA REPORT

SUBJECT: TREE REMOVAL REQUEST - 3124 COOLIDGE AVENUE

City of Costa Mesa
Maintenance Services Division
FIELD INSPECTION – TREE INFORMATION

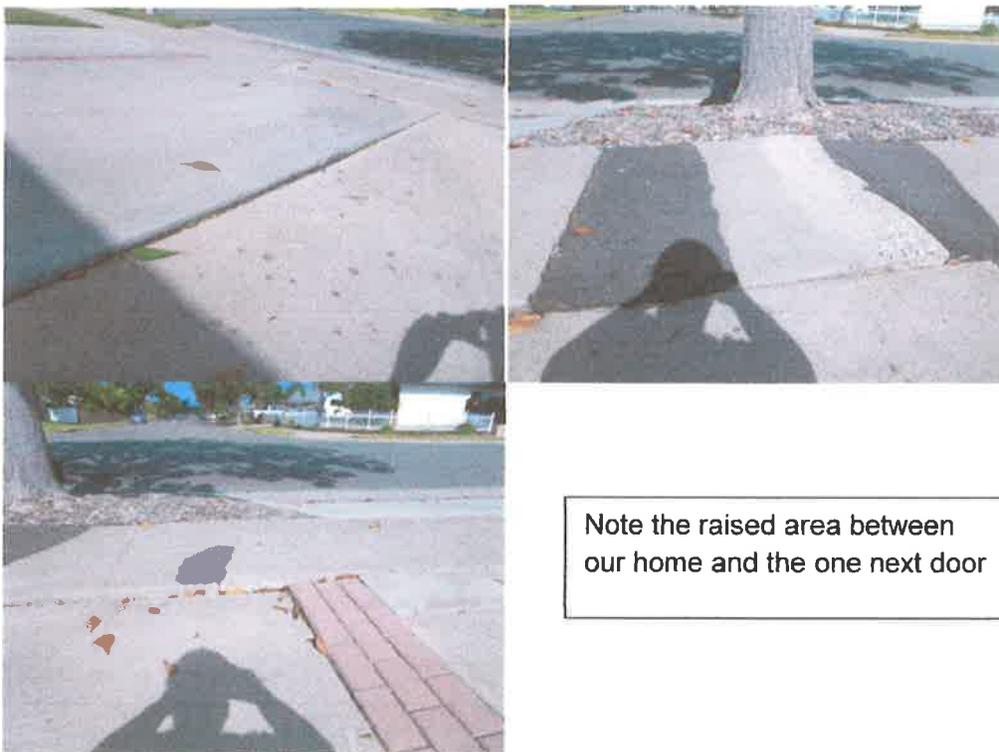
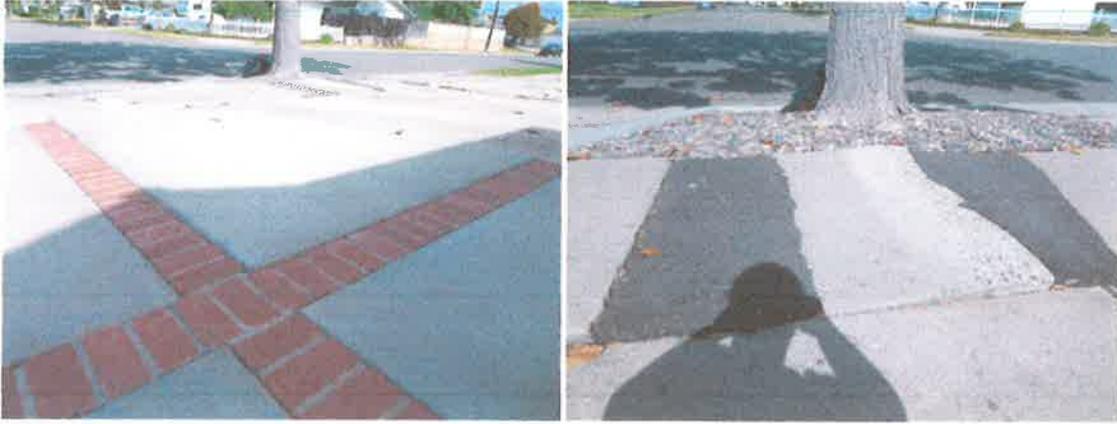
Several people were tripping on the sidewalk and on our drive way due to the damage that the tree in front of our home has caused.

Our driveway now has been affected by the tree roots and has lifted to the point that it is very dangerous.

Here are some pictures showing the raised driveway and sidewalk.

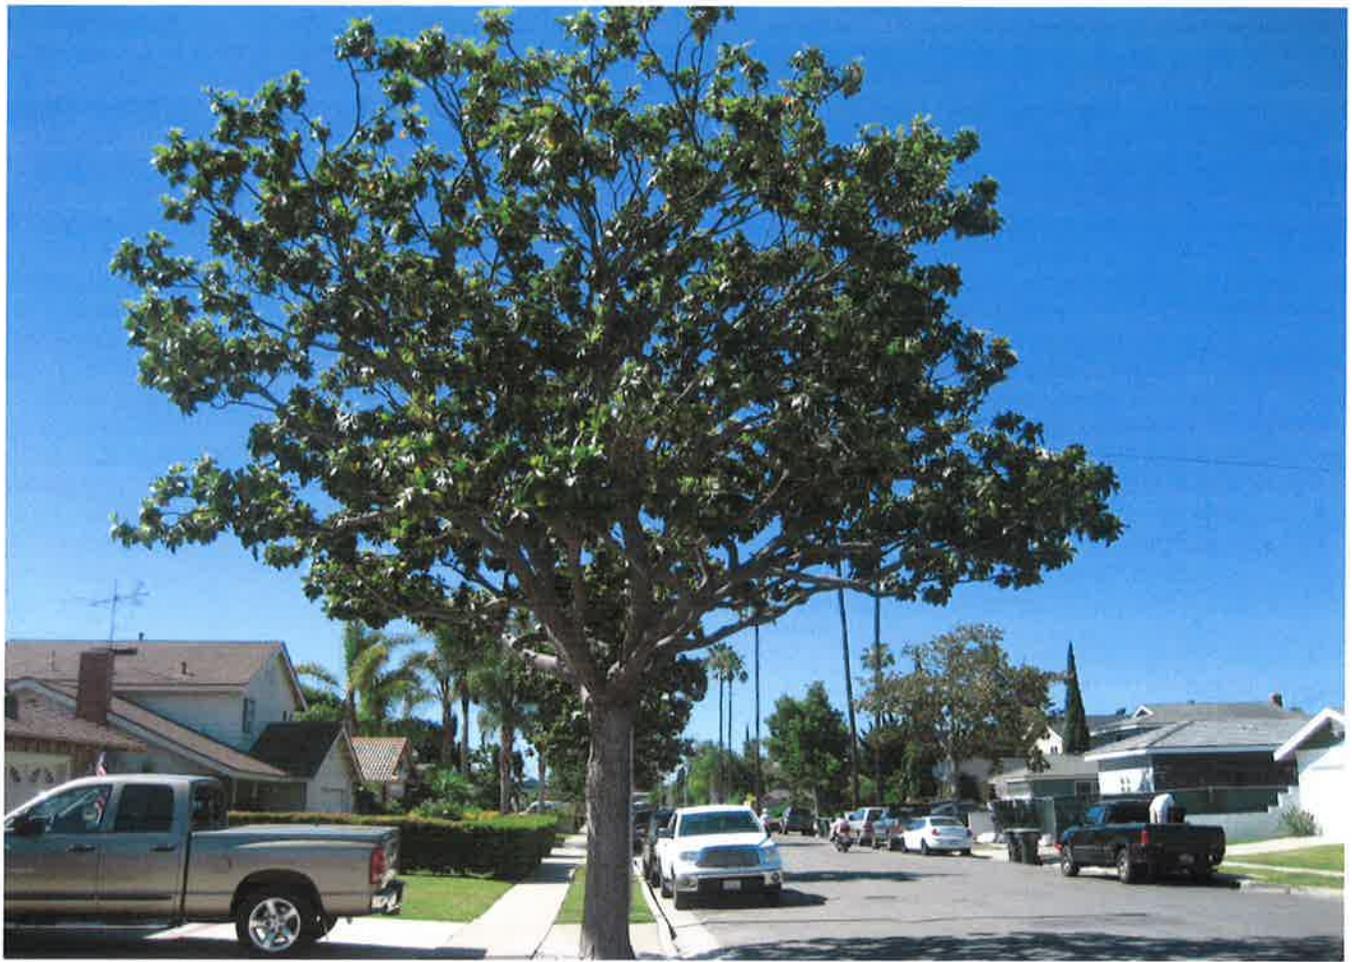
Photo #1: **Street view looking east**

If Yes, describe damage: **Sidewalk and drive approach lifted.**

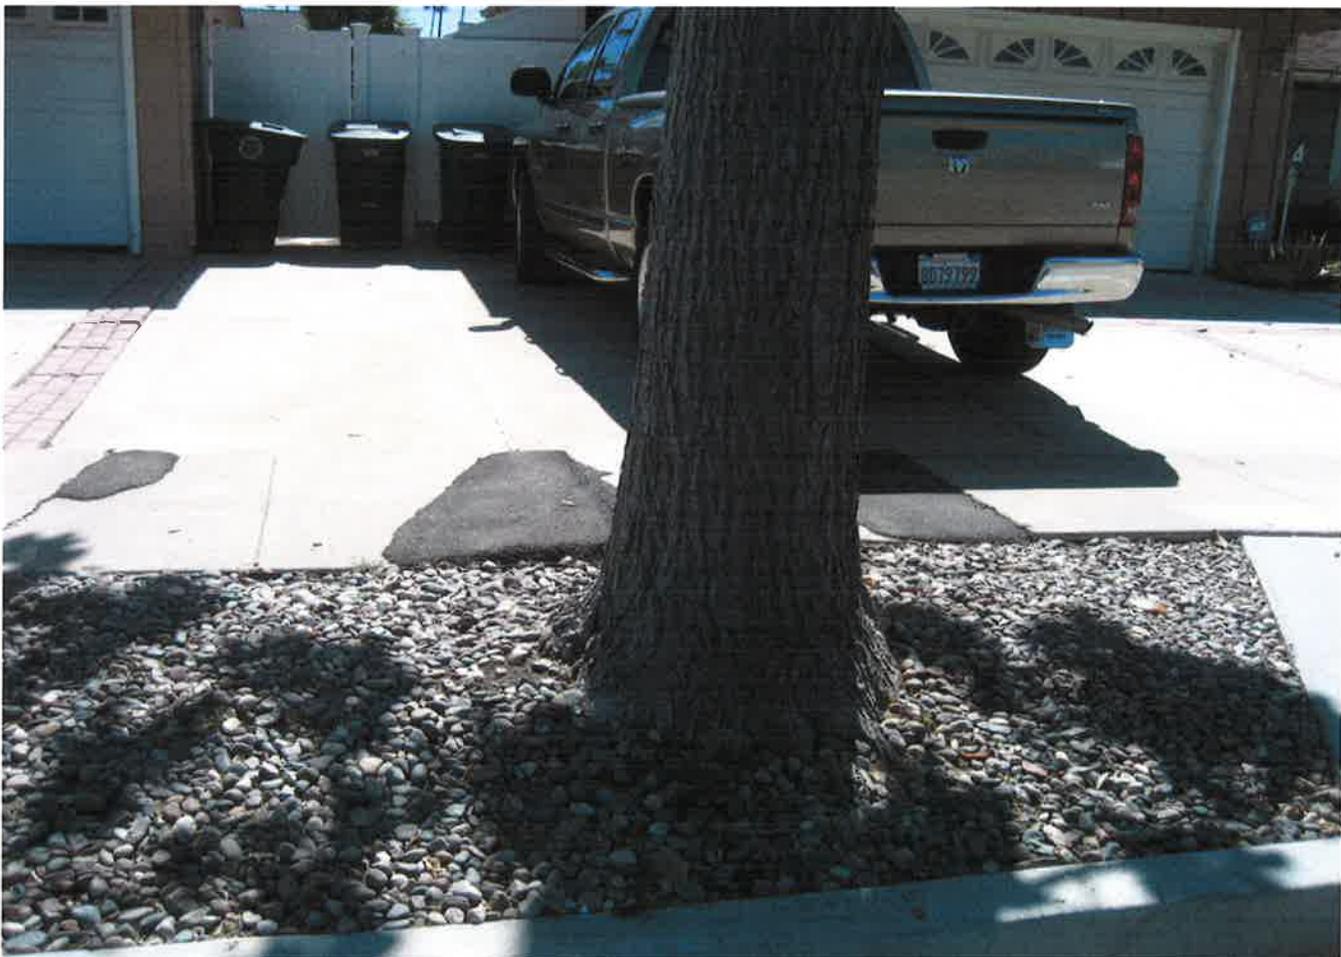
Photo #4: **Base of tree**

Root Pruning Comments: **Tree previously root pruned. Tree is growing in a small grow space, root pruning may compromise stability.**
